Climate risk mapping for Government of Yukon building assets

May 2023

Work on this project uses YG buildings as a case study for developing and testing these hazard exposure maps. This report outlines the methods and information used to create the maps developed and presented to the EMU. The maps and data are provided in an accessible and adaptable format so that they may be updated and/or adapted in the future.

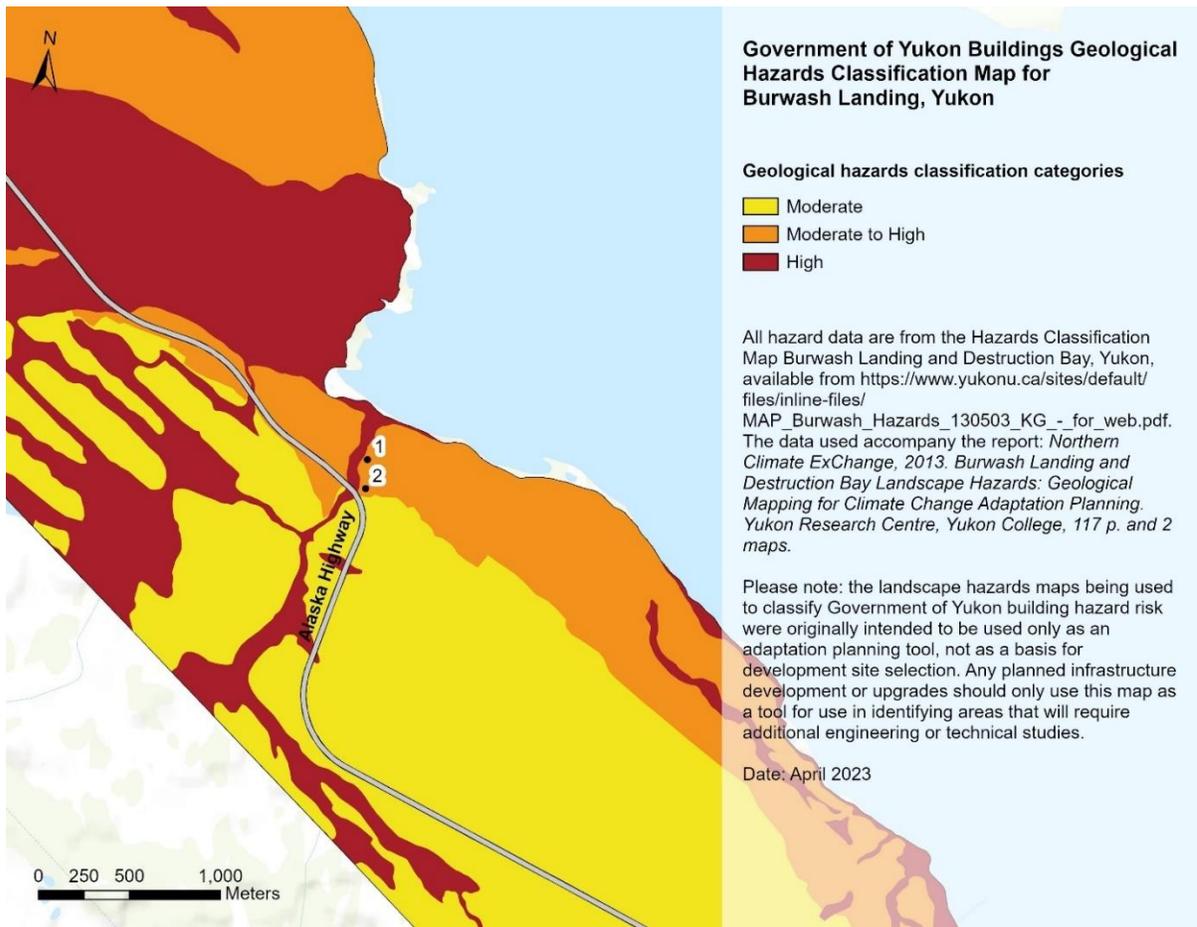
Figure 3.2.1 Government of Yukon Buildings Geological Hazards Classification Map for Burwash Landing.

The report that accompanies the hazards classification map for Burwash Landing and Destruction Bay (Northern Climate ExChange 2013) classifies geological hazards as:

Green: no risk of permafrost degradation, no risk of geologic hazards.

Yellow: moderate risk of permafrost degradation (i.e., moderate thaw settlement) or moderate risk of geologic hazards.

Orange: moderate to high risk of permafrost degradation (i.e., moderate thaw settlement on flat terrain, poor drainage, and slow mass movement on slopes due to high pore water pressure) and moderate risk of geologic hazards.

Red: moderate to high risk of permafrost degradation (i.e., high thaw settlement, water ponding, and slow to rapid mass movement on slopes due to excess pore water pressure) and/or high risk of geologic hazards.

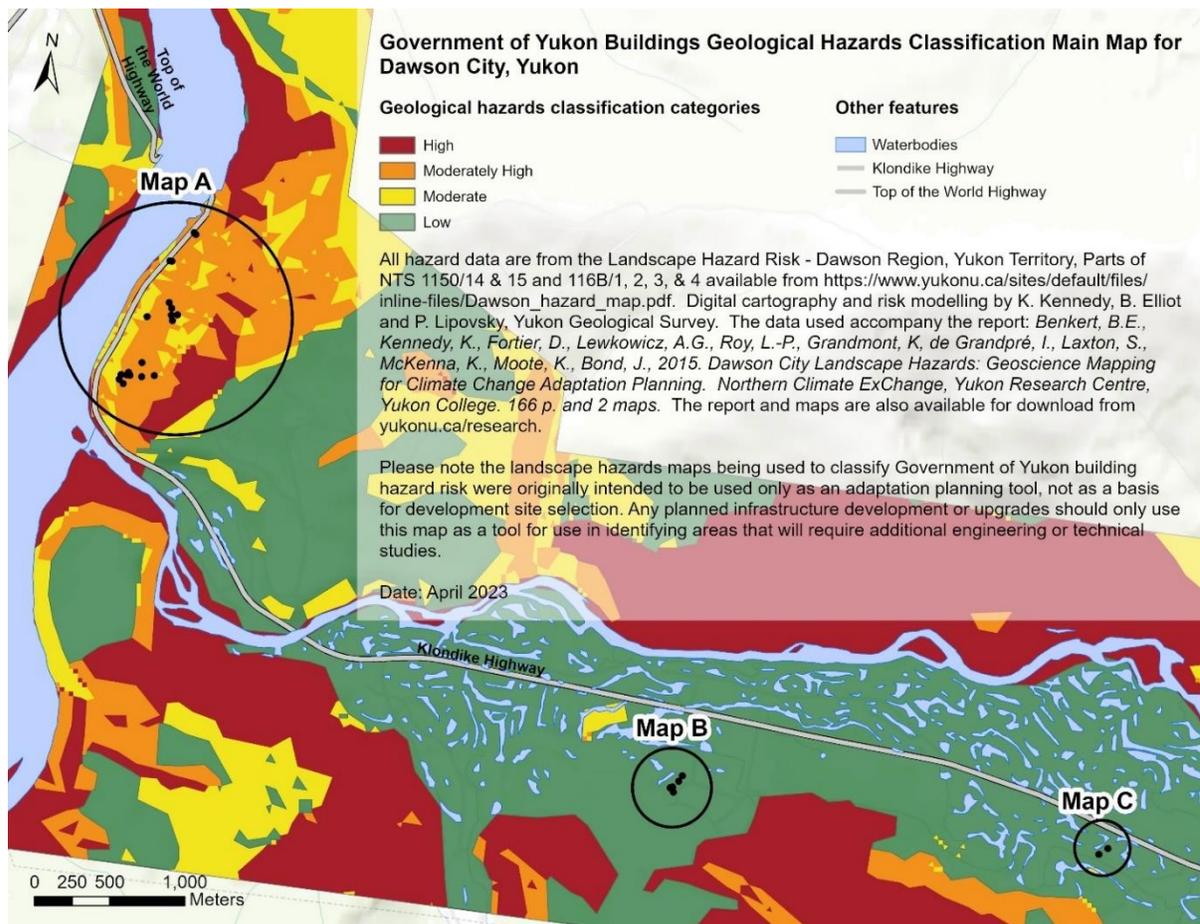
Figure 3.3.1 Government of Yukon Buildings Geological Hazards Classification Main Map for Dawson City.

The report that accompanies the hazards classification map for Dawson City (Benkert, Kennedy, et al. 2015) classifies the geological hazards as:

Green: Low risk. Characterized by flat to gently sloped terrain with south and west-facing slopes. Low-risk terrain is found above modern floodplains and is often comprised of well-drained gravel or weathered bedrock surface materials. Low-risk terrain may contain permafrost, but it is less likely to be ice rich compared with more hazardous terrain.

Yellow: Moderate risk. Characterized by gentle to moderate slopes and occurs more commonly on west and south-facing slopes. Moderate-risk terrain is found on the steep edges and cold aspects of low-risk landforms (i.e., fluvial terraces and north-facing, high-elevation slopes). Moderate-risk terrain also occurs in coarse-grained (gravel) surficial materials that may be affected by ice-rich permafrost (e.g., downtown Dawson).

Orange: Moderately high risk. Characterized by moderate to steep slopes and east to north-facing slopes. Moderately high-risk terrain is found on all aspects in the study area and is common in narrow, steep-sided valleys and on more gentle slopes where permafrost is more likely to be present. The difference between moderate and moderately high-risk terrain in the study area is often based on changes in slope angle and slope aspect.

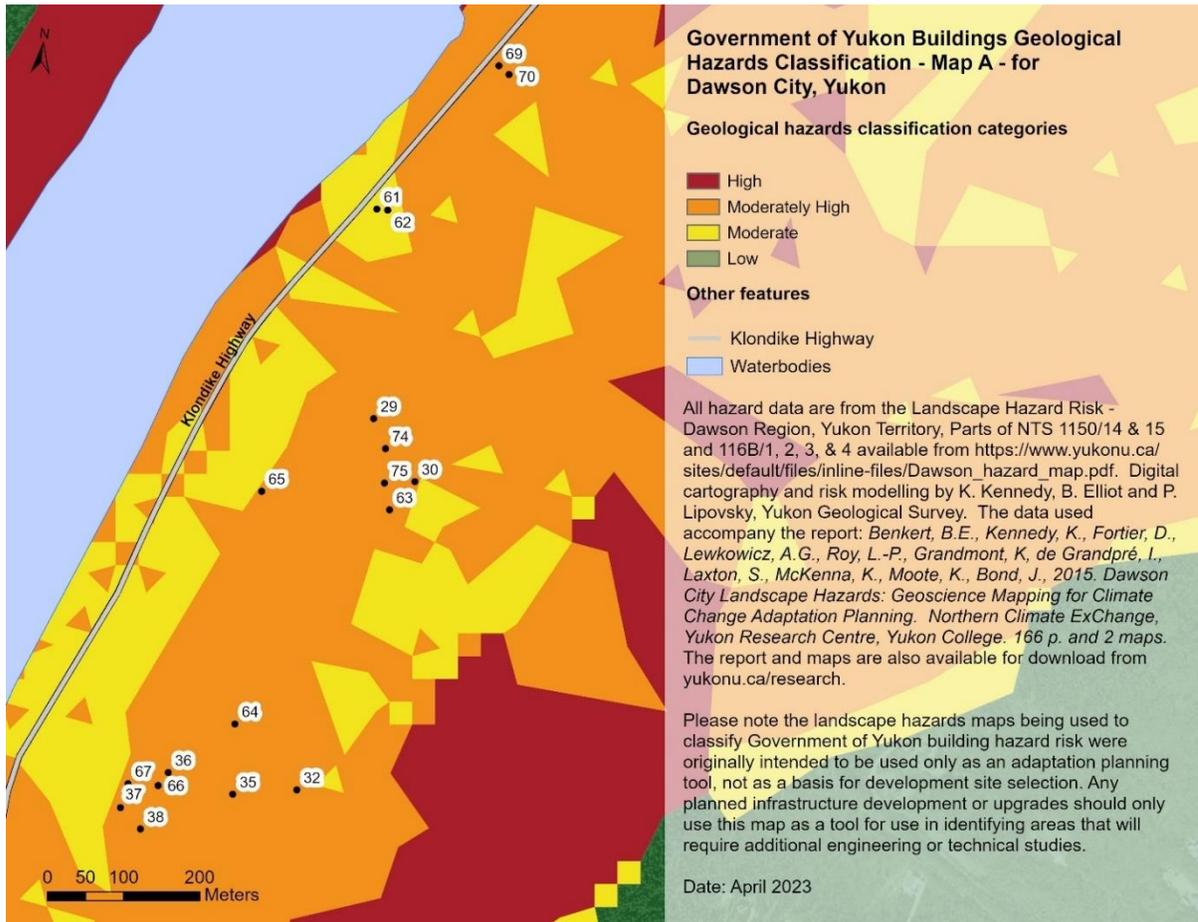
Figure 3.3.2 Government of Yukon Buildings Geological Hazards Classification – Map A - for Dawson City.

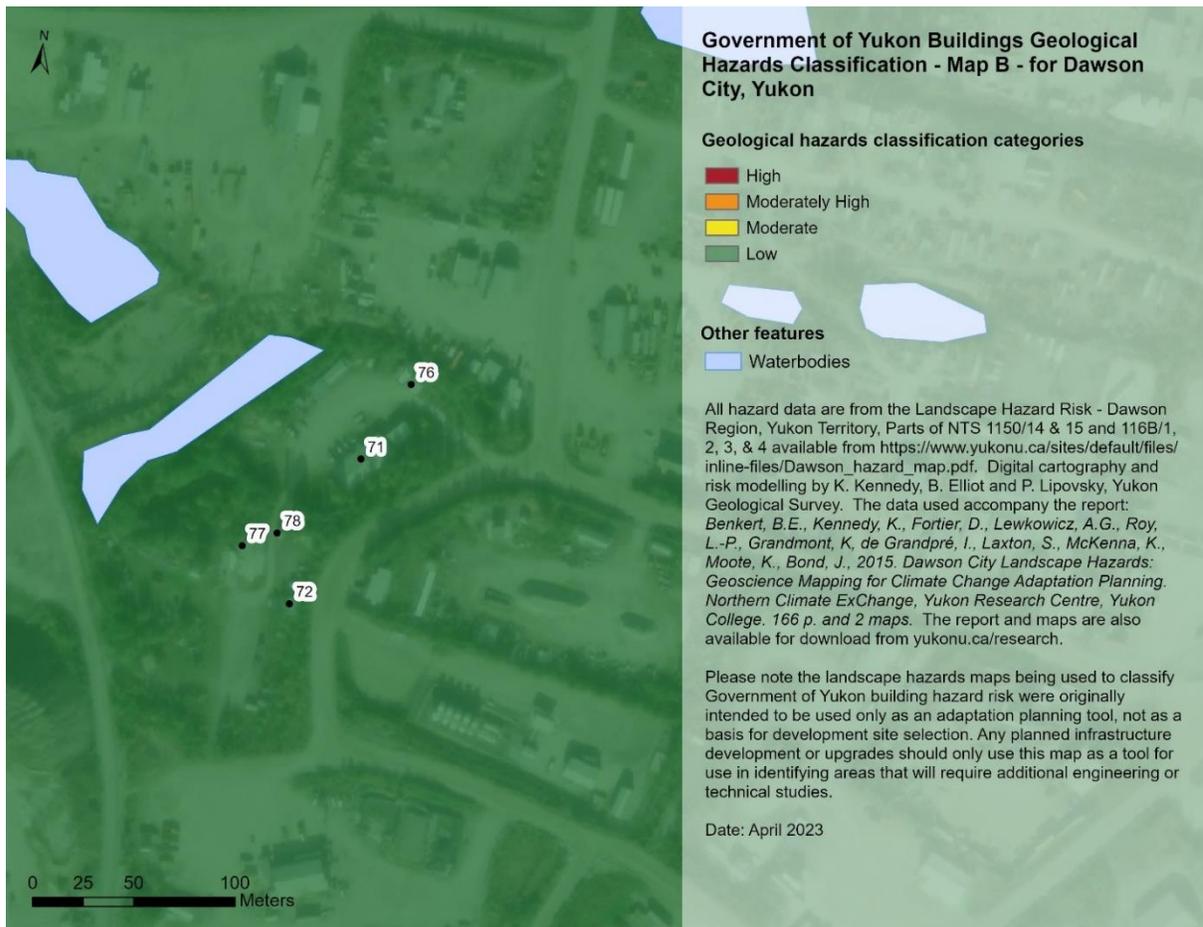
Figure 3.3.3 Government of Yukon Buildings Geological Hazards Classification – Map B - for Dawson City.

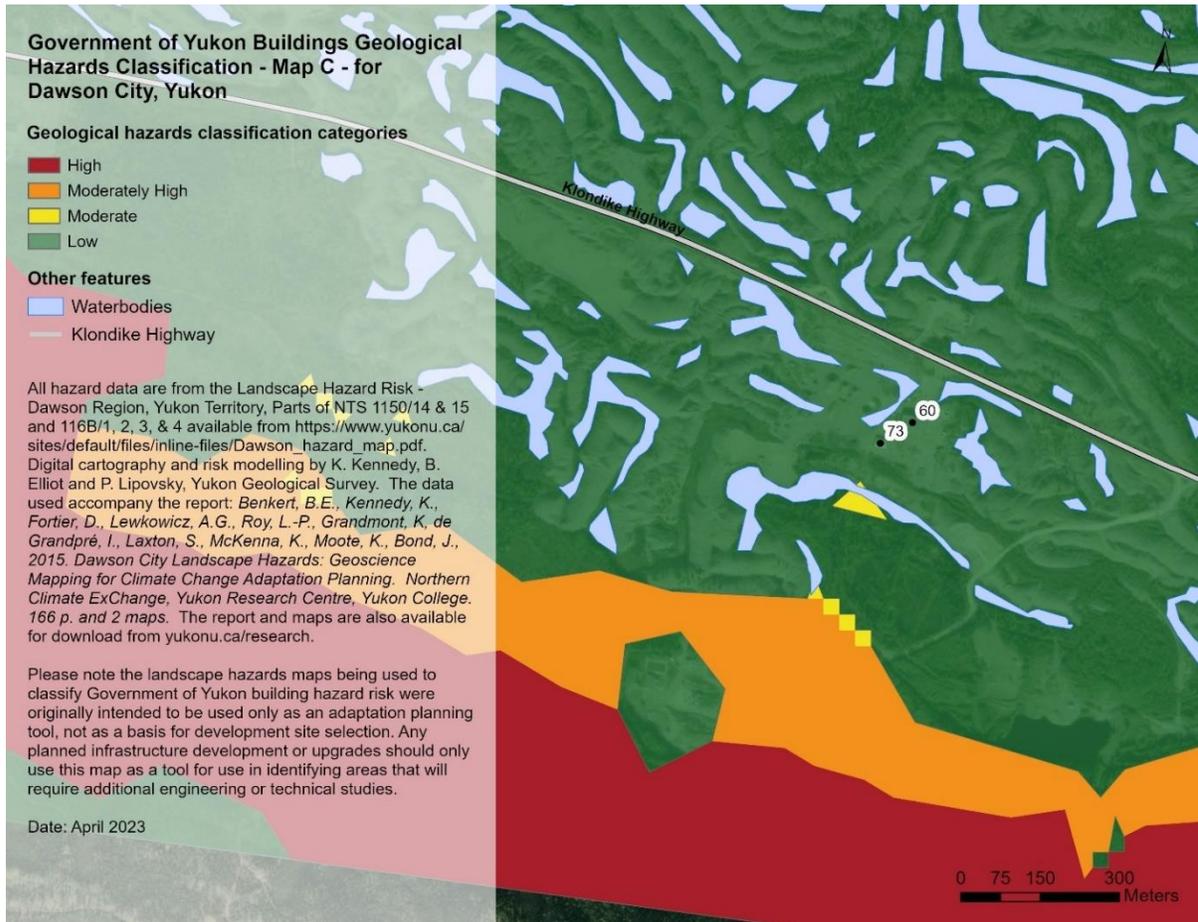
Figure 3.3.4 Government of Yukon Buildings Geological Hazards Classification – Map C - for Dawson City.

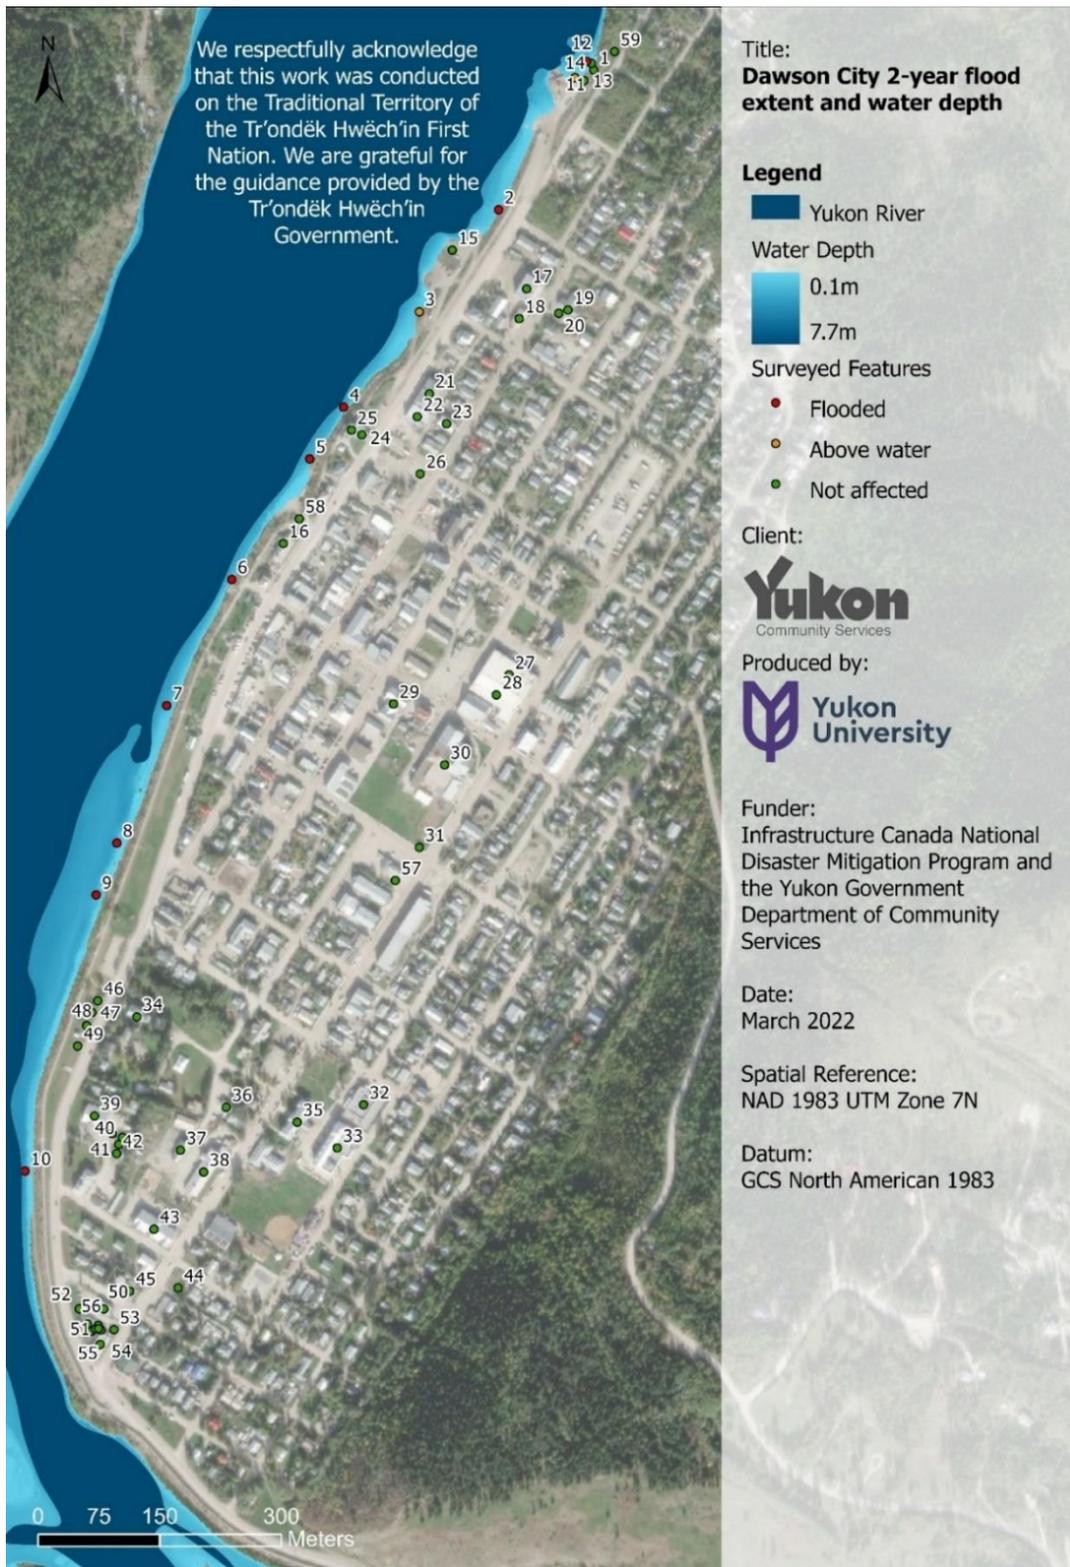
Figure 3.3.5 Dawson City 2-year flood extend and water depth.

The flood vulnerability mapping done for Dawson included a detailed survey of assets within the community and a related assessment of flood risk for those assets for each scenario. When comparing the YG building data with the surveyed assets, it was noted that only some of the YG buildings in Dawson have associated flood vulnerability information.

Below are the flood maps and table of surveyed assets with their associated flood risk. The YG buildings are highlighted in purple. Any YG buildings not listed within the table had no flood information associated with the maps below.

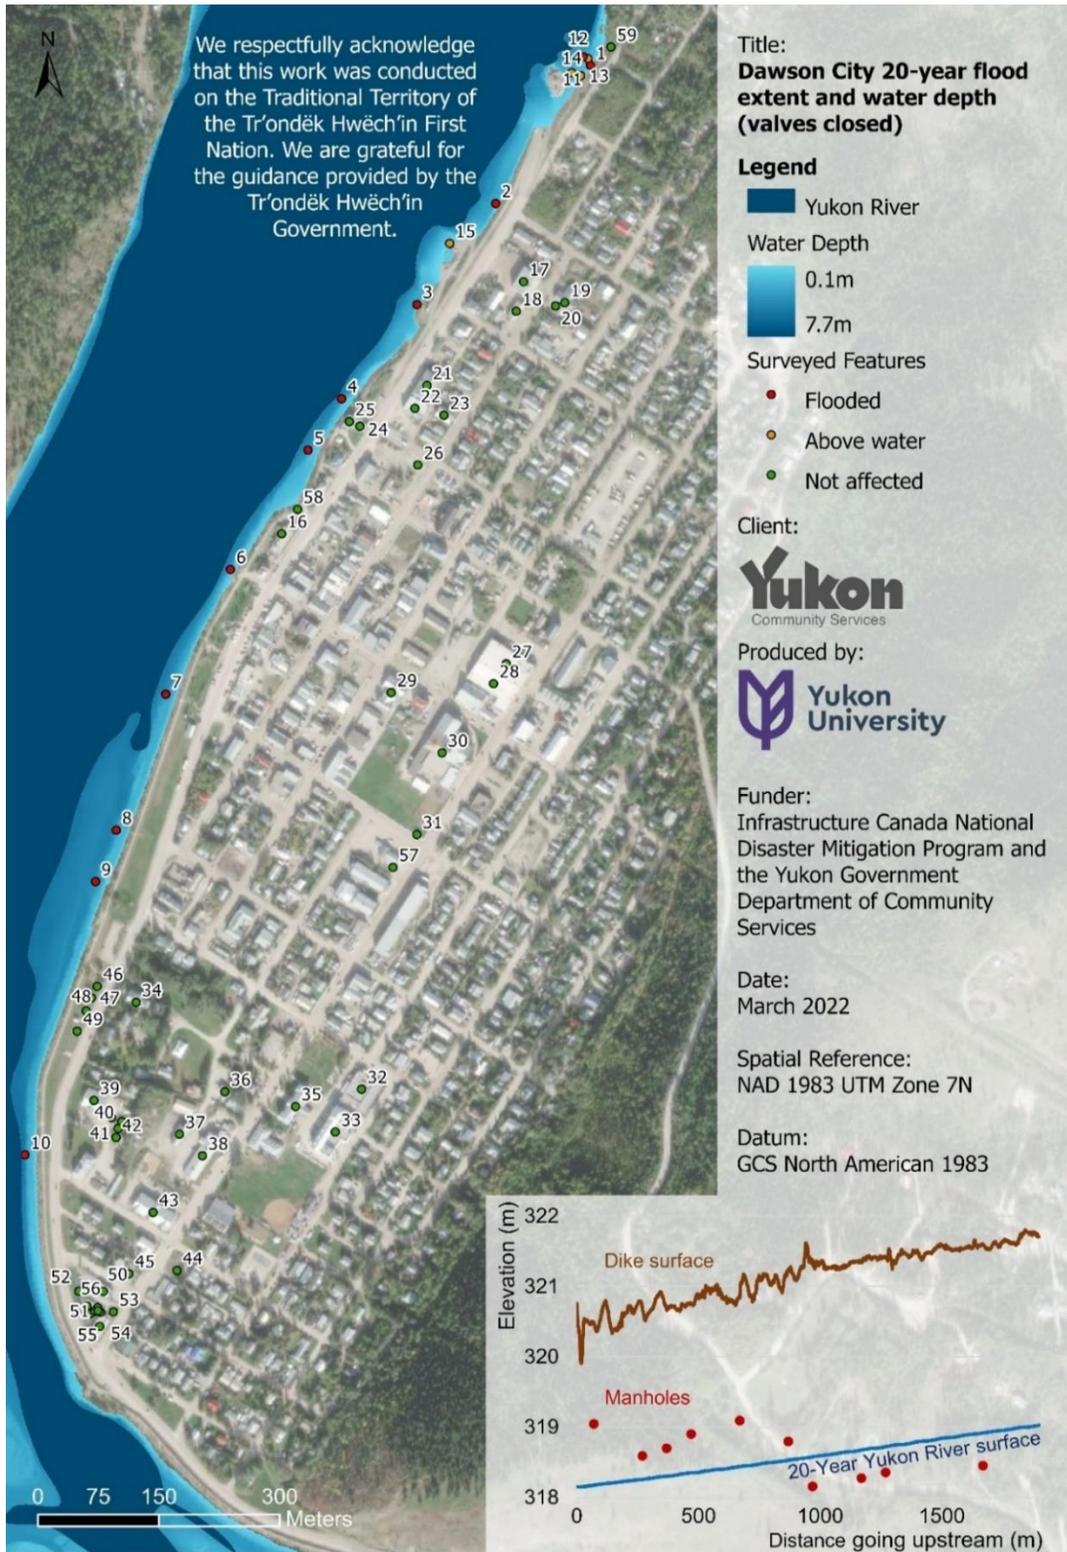
Figure 3.3.6 Dawson City 20-year flood extent and water depth (valves closed).

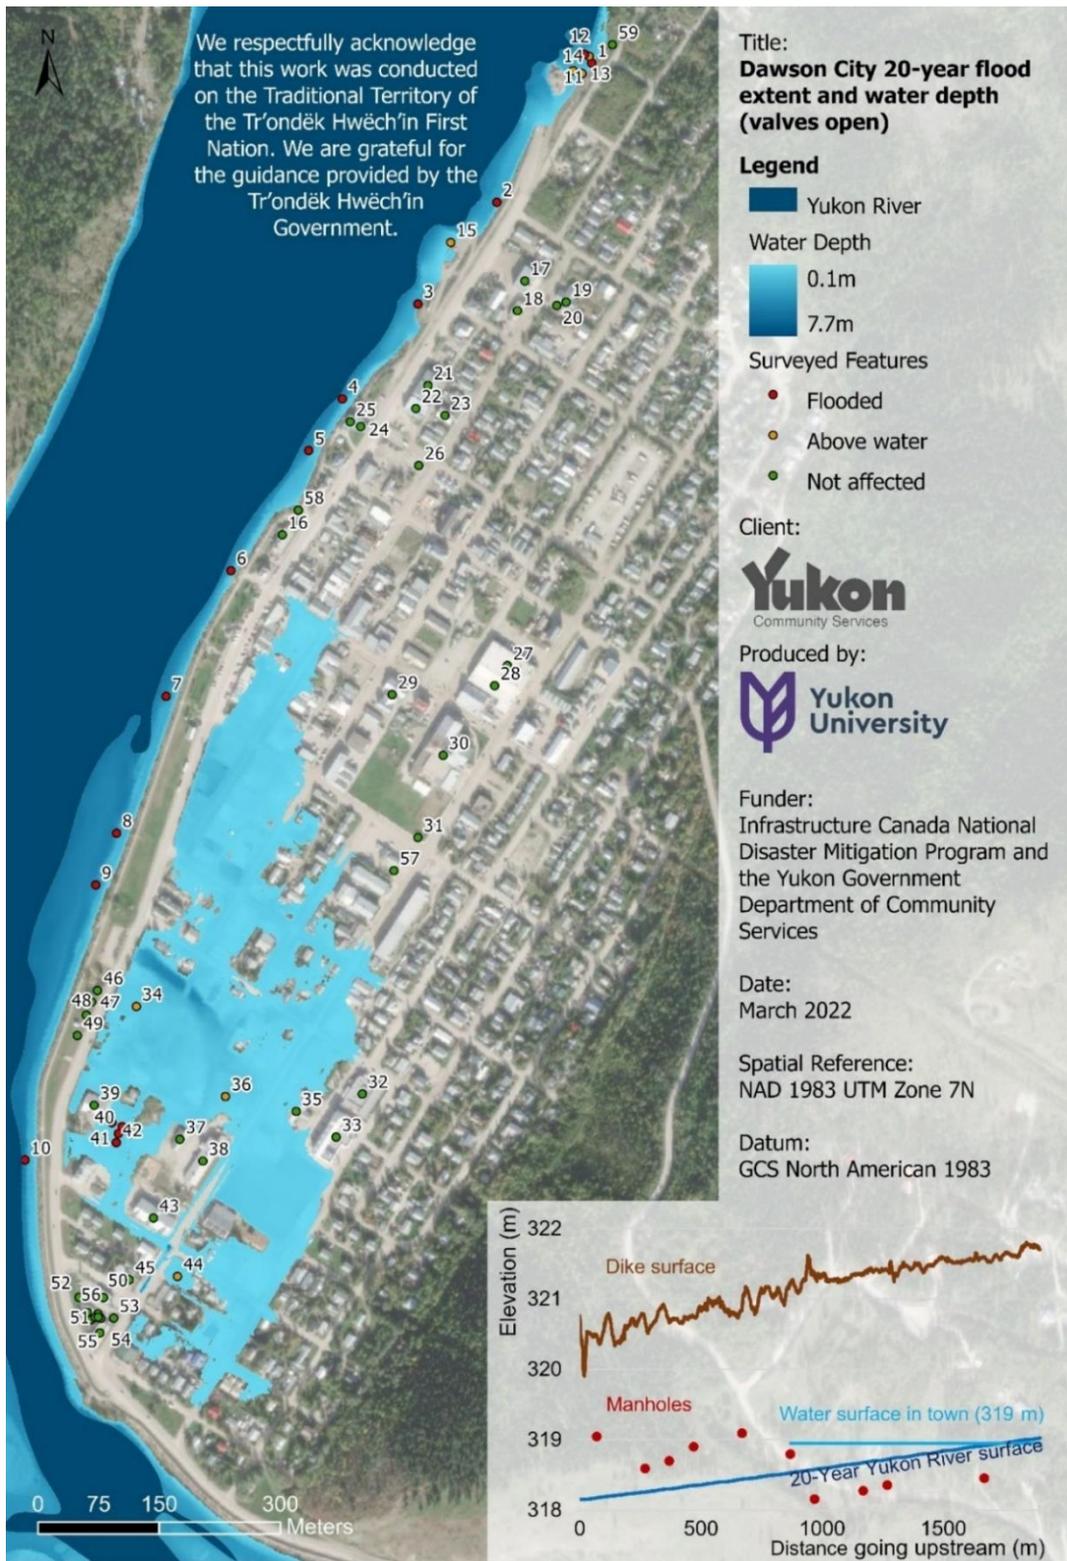
Figure 3.3.7 Dawson City 20-year flood extent and water depth (valves open).

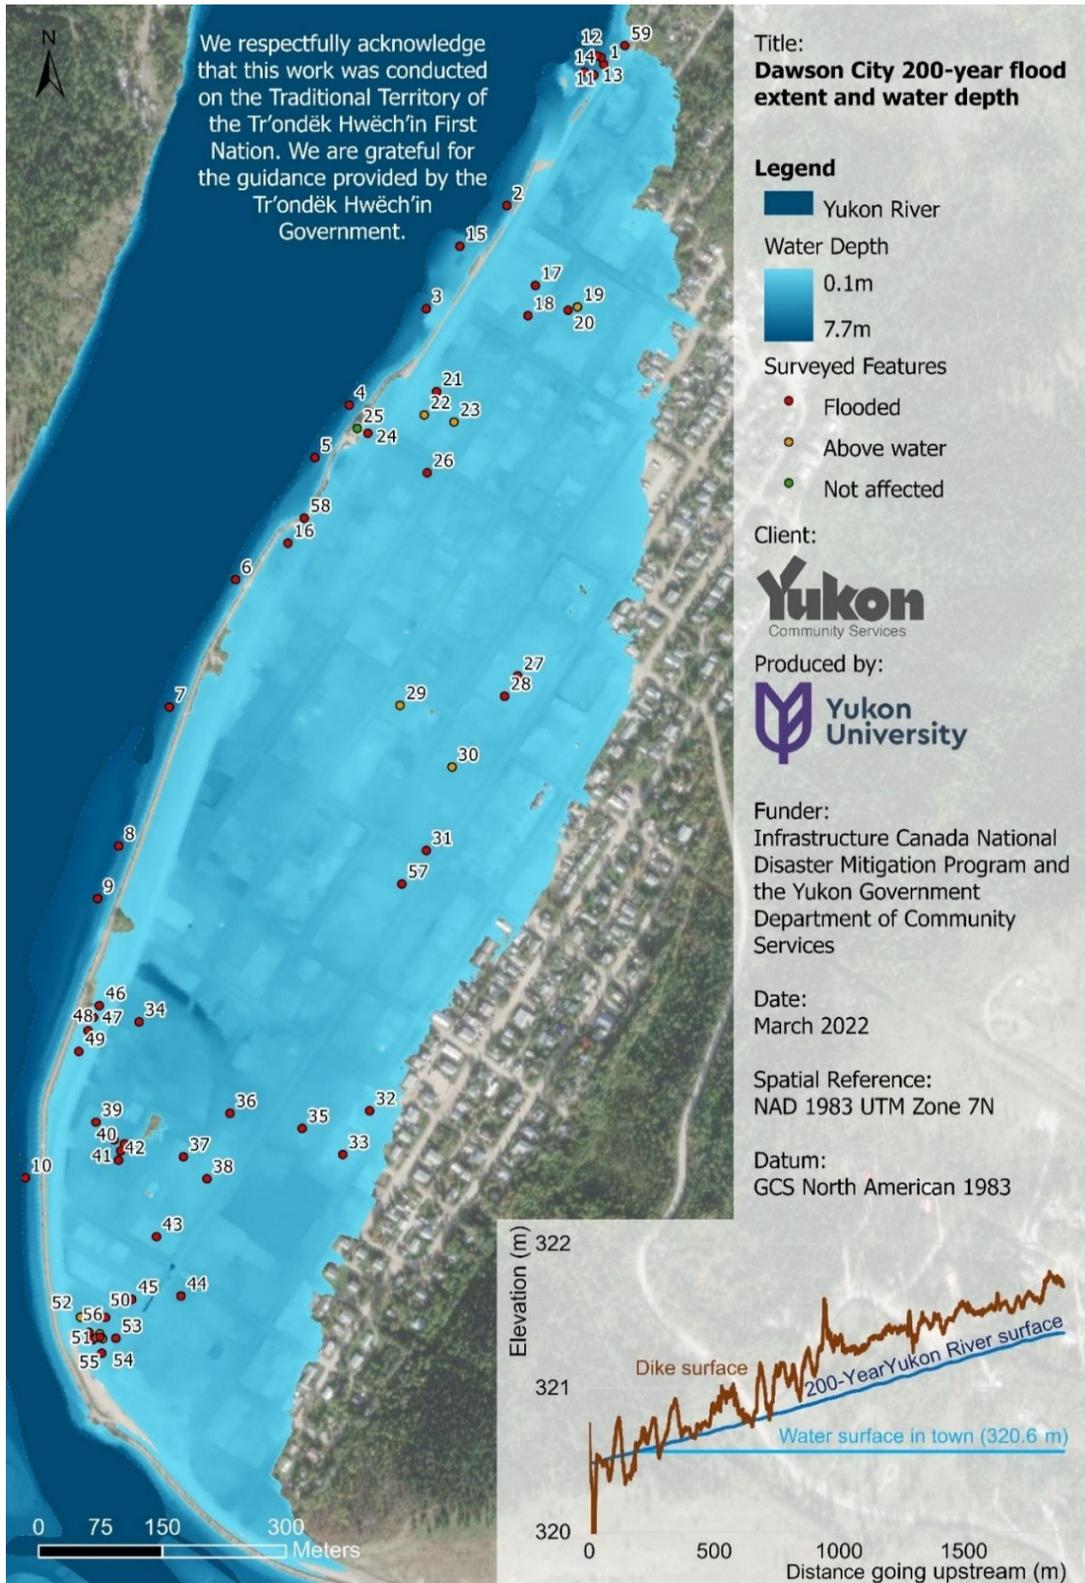
Figure 3.3.8 Dawson City 200-year flood extent and water depth.

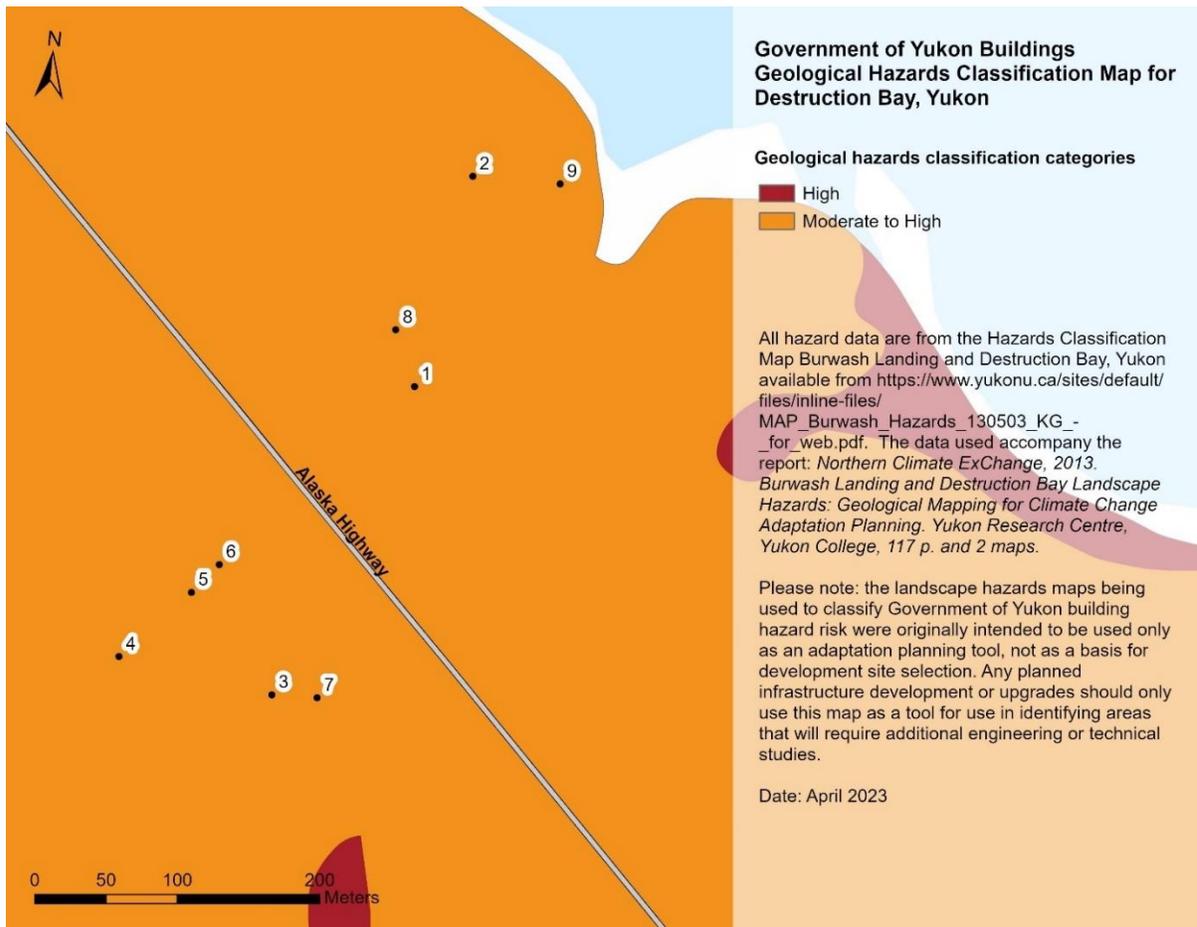
Figure 3.4.1 Government of Yukon Buildings Geological Hazards Classification Map for Destruction Bay.

The report that accompanies the hazards classification map for Burwash Landing and Destruction Bay (Northern Climate ExChange 2013) classifies the geological hazards as:

Green: no risk of permafrost degradation, no risk of geologic hazards.

Yellow: moderate risk of permafrost degradation (i.e., moderate thaw settlement) or moderate risk of geologic hazards.

Orange: moderate to high risk of permafrost degradation (i.e., moderate thaw settlement on flat terrain, poor drainage, and slow mass movement on slopes due to high pore water pressure) and moderate risk of geologic hazards.

Red: moderate to high risk of permafrost degradation (i.e., high thaw settlement, water ponding, and slow to rapid mass movement on slopes due to excess pore water pressure) and/or high risk of geologic hazards.

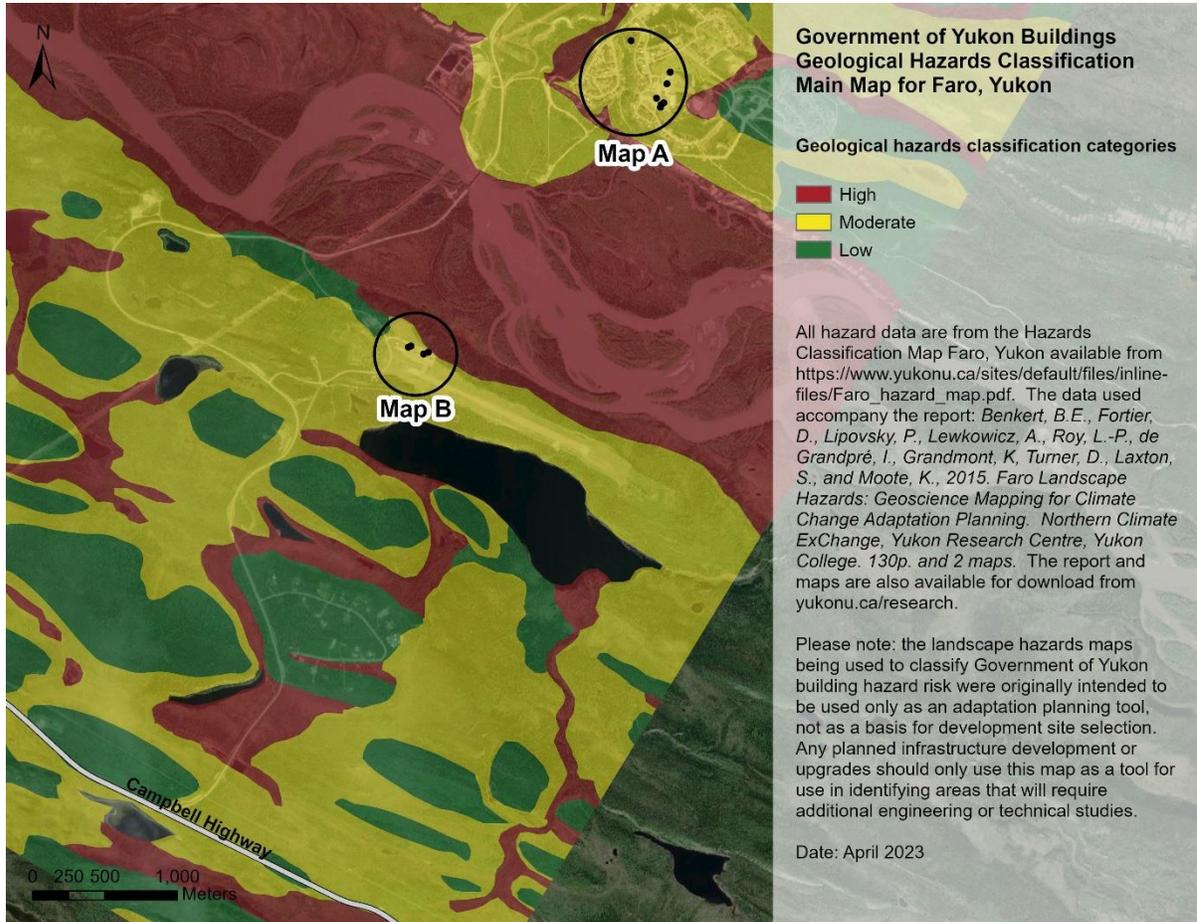
Figure 3.5.1 Government of Yukon Buildings Geological Hazards Classification Main Map for Faro.

The report that accompanies the hazards classification map for Faro (Benkert, Fortier, Lipovsky, Lewkowicz, Roy, et al. 2015) classifies the geological hazards as:

Green: low risk of hazards following permafrost degradation, low risk of geomorphic hazards.

Red: high risk of hazards following permafrost degradation (e.g., high thaw settlement, water ponding, and slow to rapid mass movement on slopes) and/or high risk of geomorphic hazards (e.g., gullying, flooding, steep slopes).

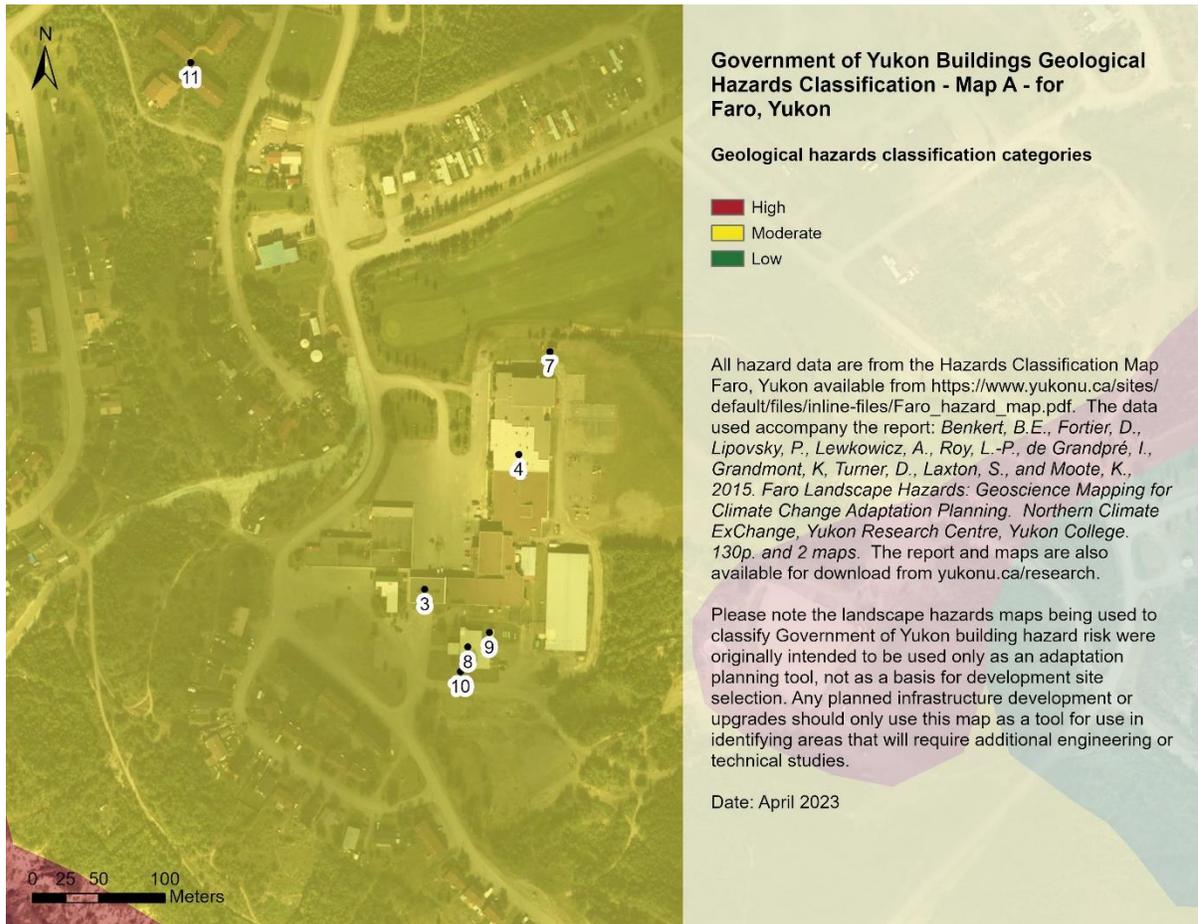
Figure 3.5.2 Government of Yukon Buildings Geological Hazards Classification – Map A - for Faro.

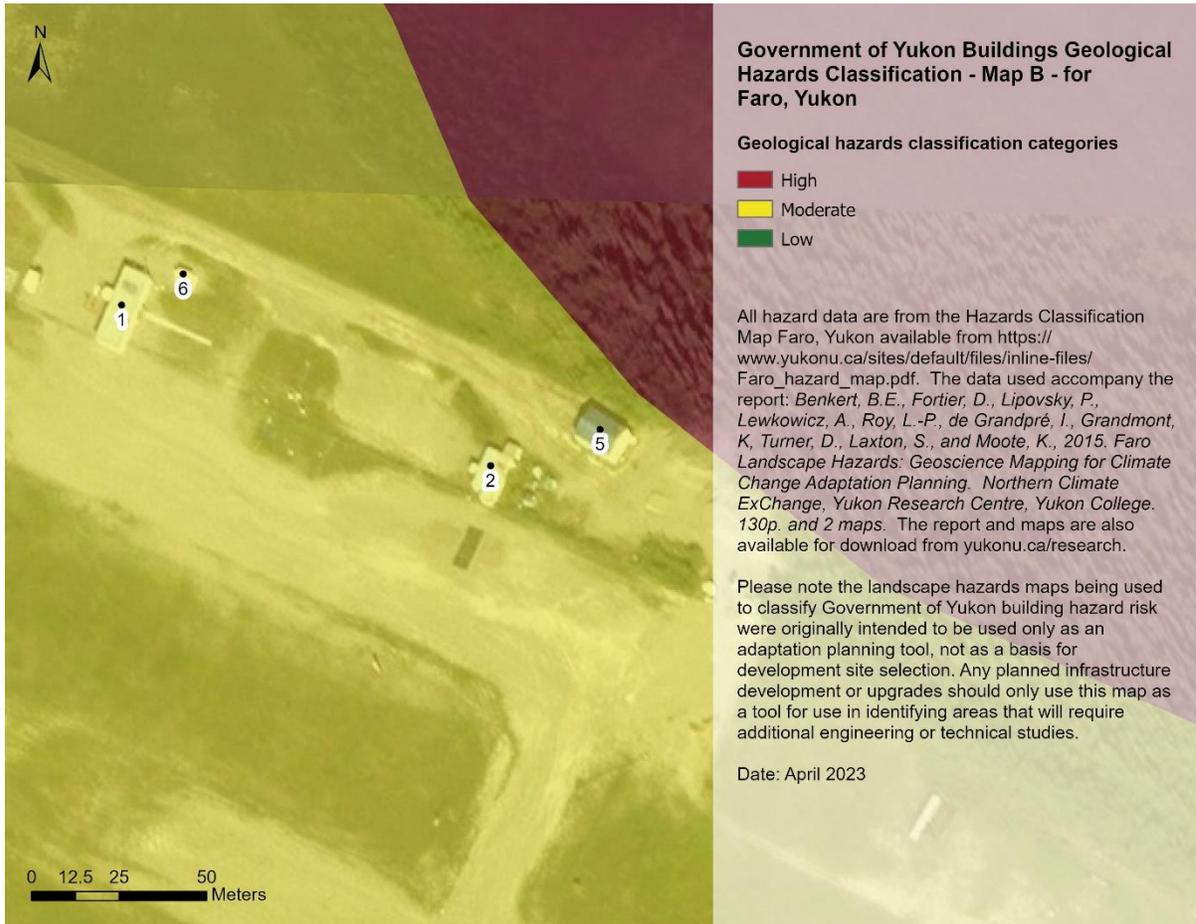
Figure 3.5.3 Government of Yukon Buildings Geological Hazards Classification – Map B - for Faro.

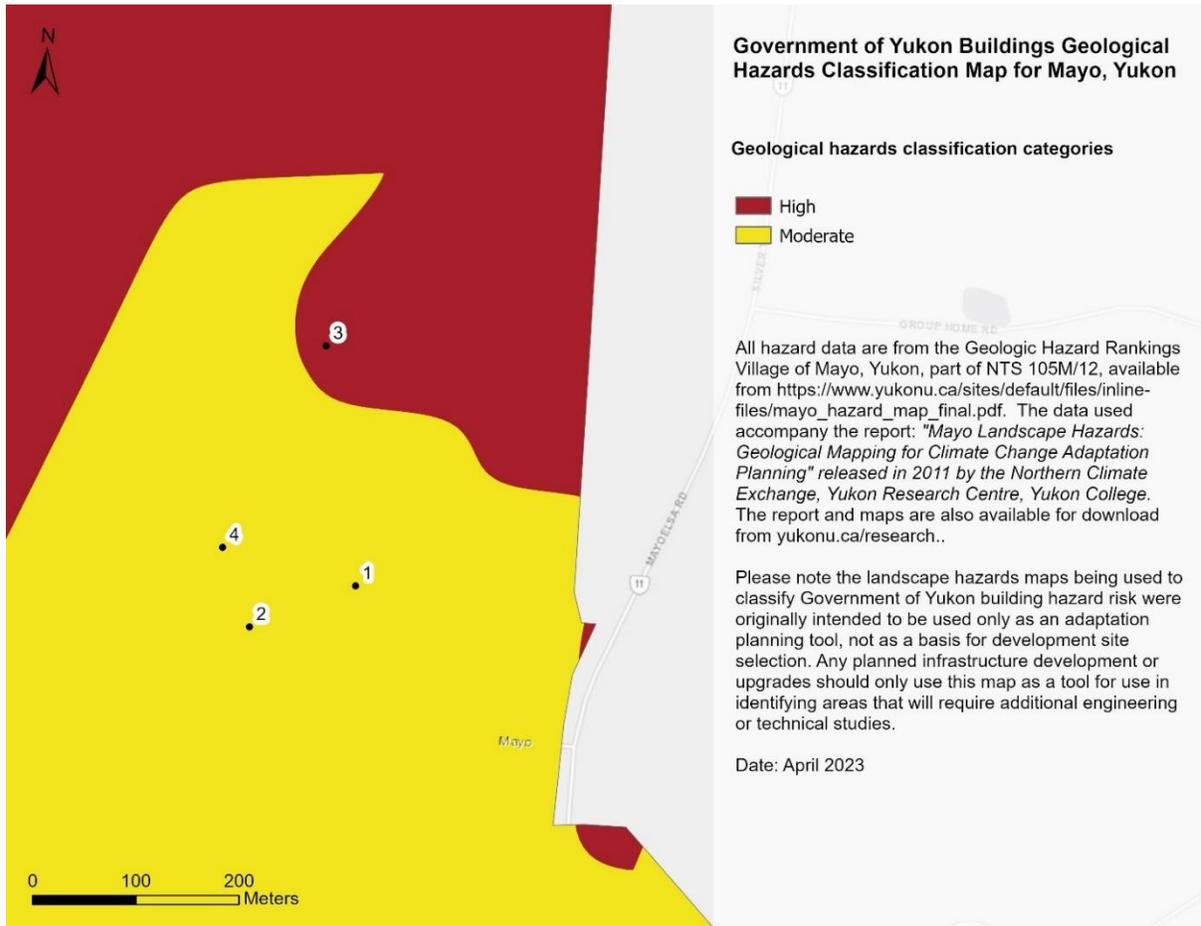
Figure 3.6.1 Government of Yukon Buildings Geological Hazards Classification Map for Mayo.

Red: High - Unstable landform. Likely to be affected by mass movement, thermokarst, subsidence, bank erosion, flooding or instability. These landforms typically consist of glacial diamicts, colluvial materials, glaciolacustrine, lacustrine and fluvial deposits. They are generally moderately to poorly drained and have shallow to steep slopes. High hazard landforms may have a significant thickness of permafrost containing high ice contents, be prone to gravity-induced erosion, and occur within the floodplain of the Stewart or Mayo rivers.

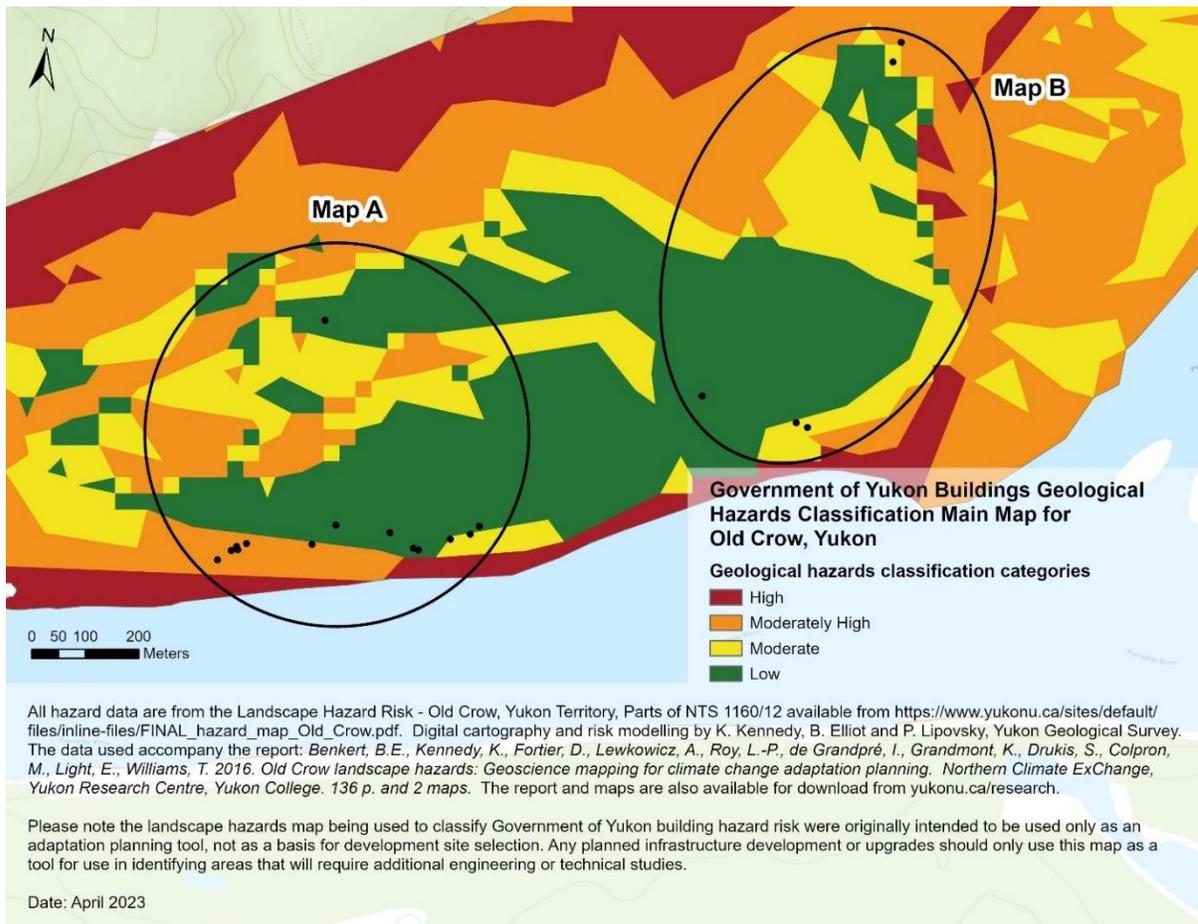
Figure 3.7.1 Government of Yukon Buildings Geological Hazards Classification Main Map for Old Crow.

Red: High-Risk terrain in the Old Crow area is characterized by steep slopes and warm aspects (i.e., west and south facing). It is characterized by an increased risk of landslides. High risk terrain in the study area occurs in areas with documented landslide debris, paths, or features of slow mass movement such as tension cracks. High-risk terrain contains both permafrost and fine-grained surficial materials on steep to very steep slopes that can easily generate landslides with significant run-out distances.

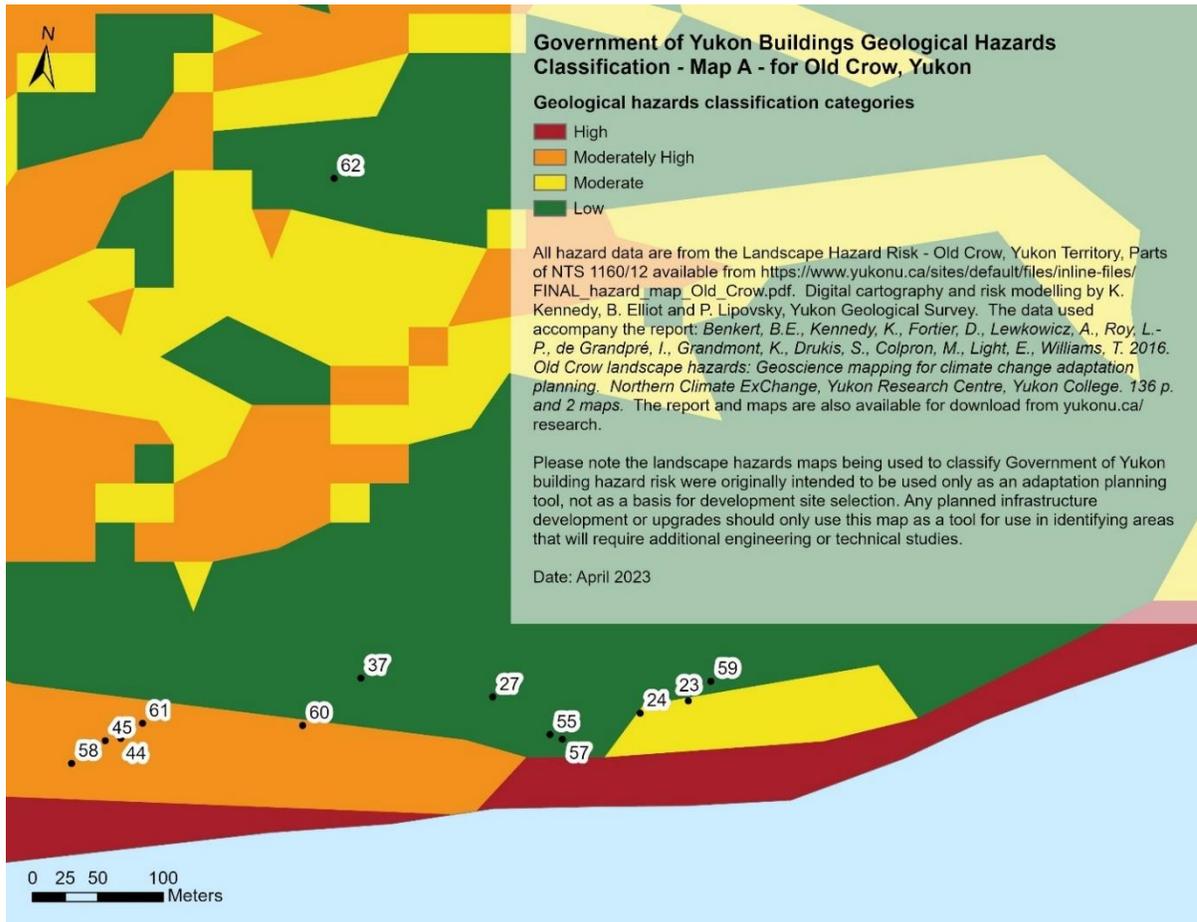
Figure 3.7.2 Government of Yukon Buildings Geological Hazards Classification – Map A - for Old Crow.

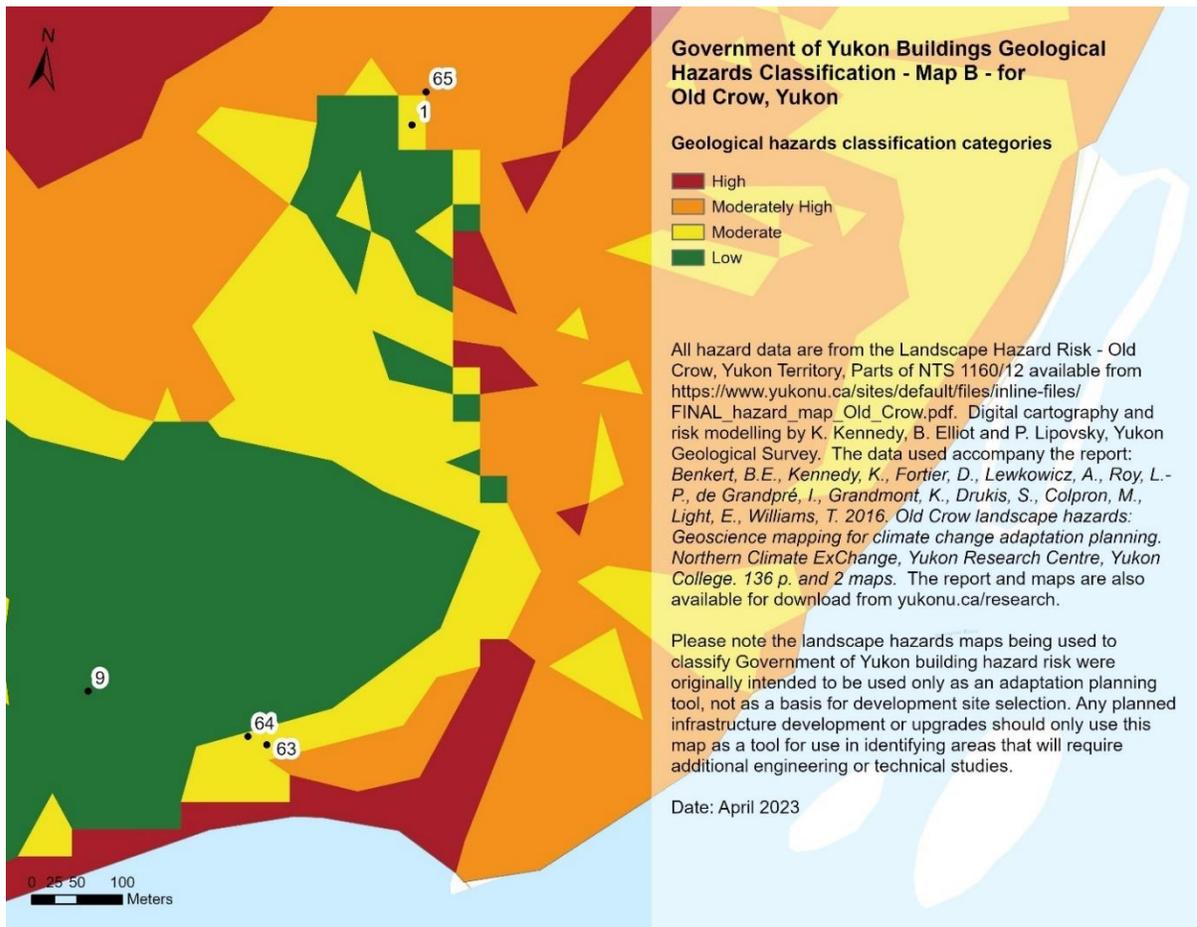
Figure 3.7.3 Government of Yukon Buildings Geological Hazards Classification – Map B - for Old Crow.
