Climate risk mapping for Government of Yukon building assets

May 2023

Work on this project uses YG buildings as a case study for developing and testing these hazard exposure maps. This report outlines the methods and information used to create the maps developed and presented to the EMU. The maps and data are provided in an accessible and adaptable format so that they may be updated and/or adapted in the future.

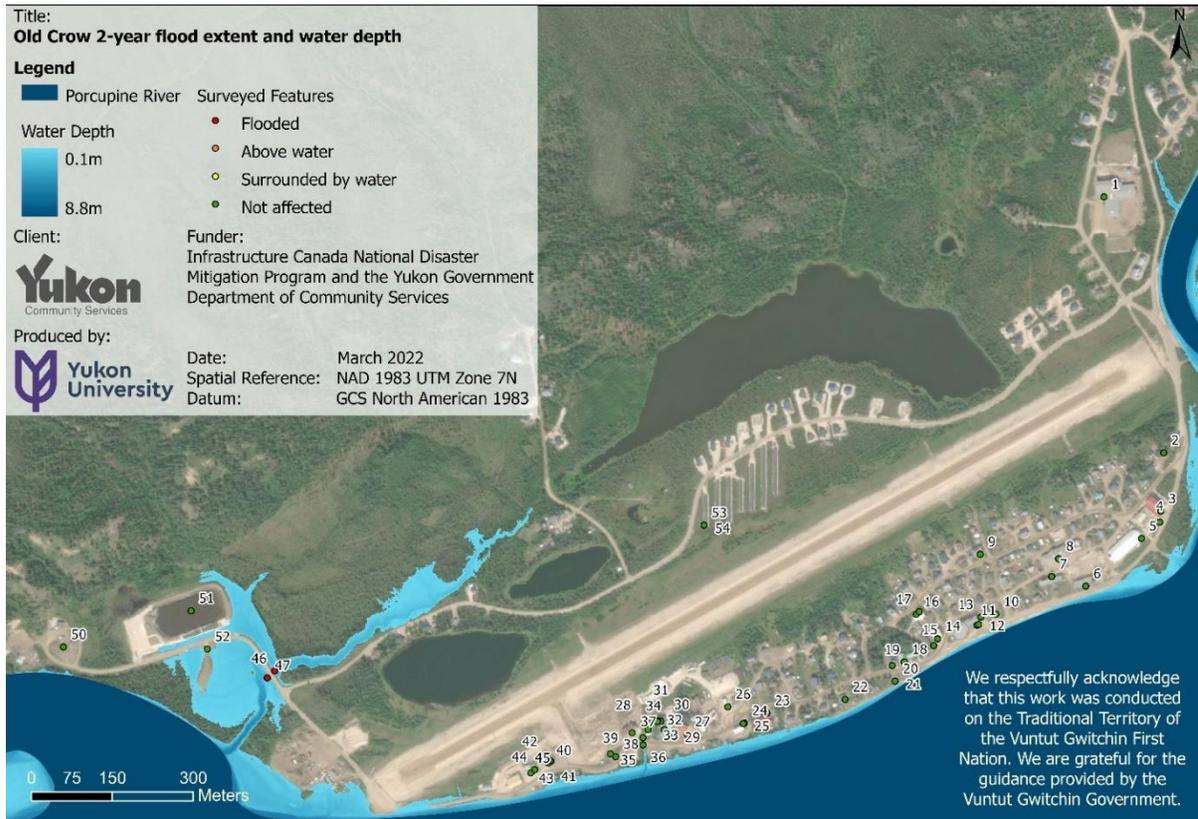
Figure 3.7.4 Old Crow 2-year flood extent and water depth.

The flood vulnerability mapping done for Old Crow included a detailed survey of assets within the community and a related assessment of flood vulnerability for those assets for the four scenarios. When comparing the YG building data with the surveyed assets, it was noted that only some of the YG buildings in Old Crow have associated flood vulnerability information.

Below are the flood vulnerability maps and table of surveyed assets with their associated flood vulnerability. The YG buildings are highlighted in purple. Any YG buildings not listed within the table had no flood information associated with the maps below.

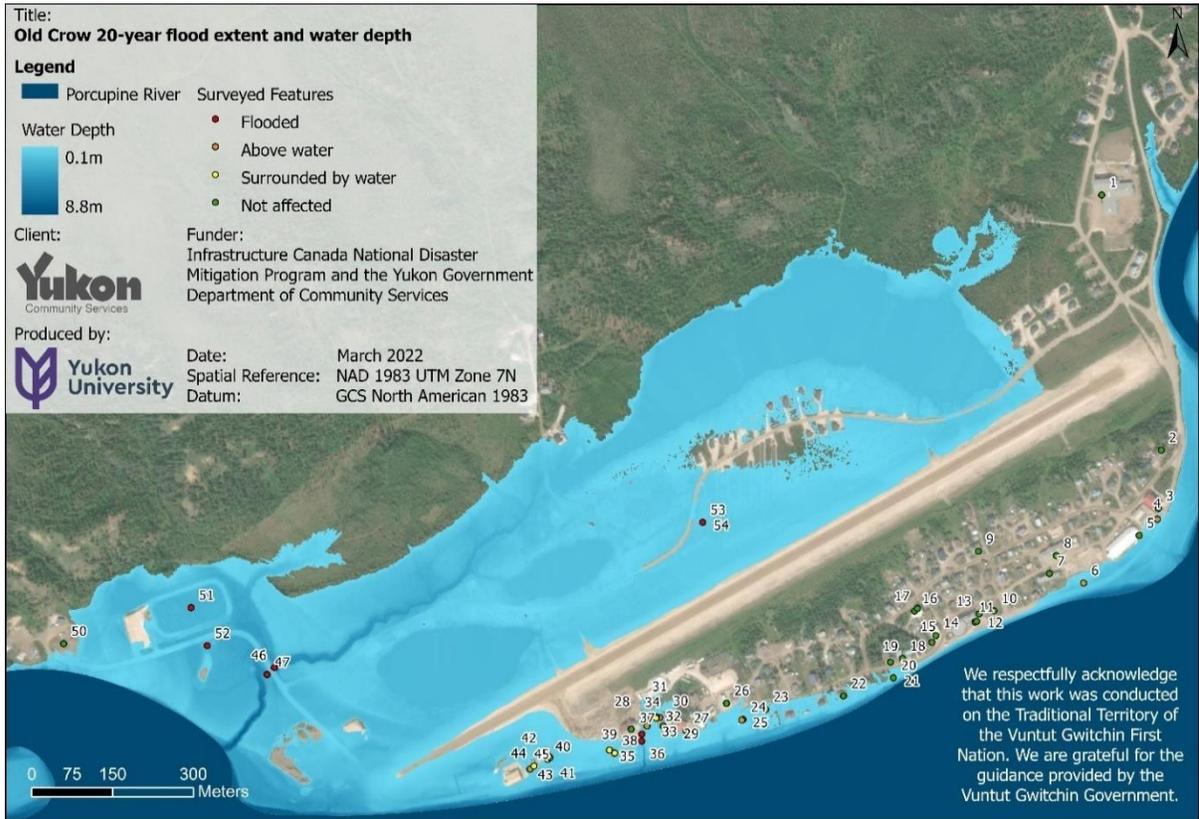
Figure 3.7.5 Old Crow 20-year flood extent and water depth.

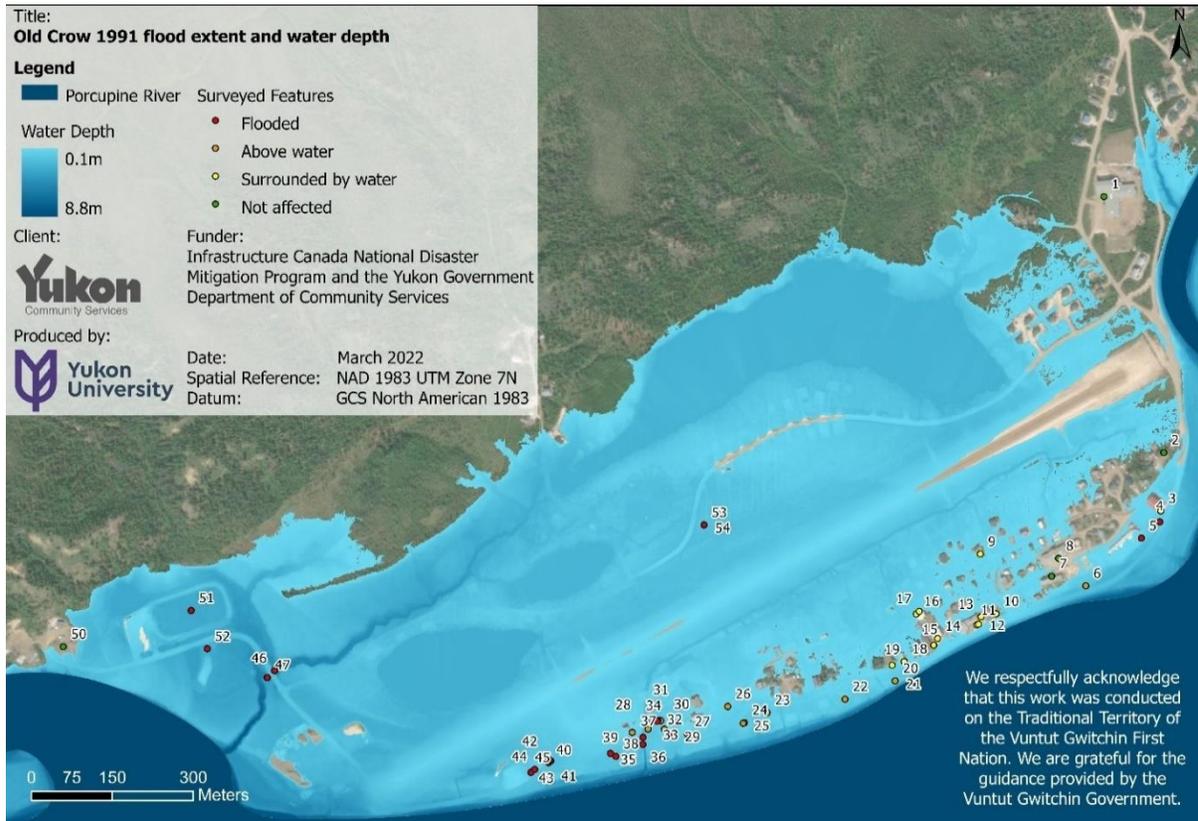
Figure 3.7.6 Old Crow 1991 flood extent and water depth.

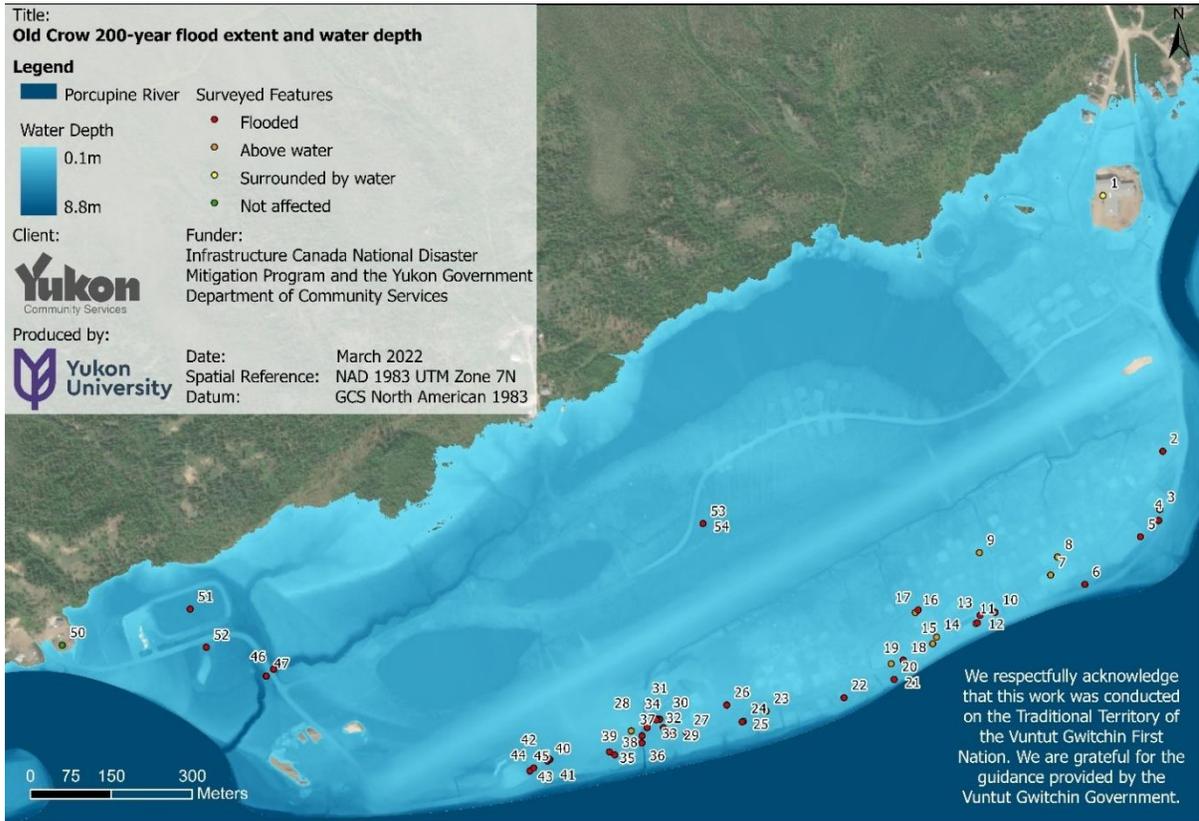
Figure 3.7.7 Old Crow 200-year flood extent and water depth.

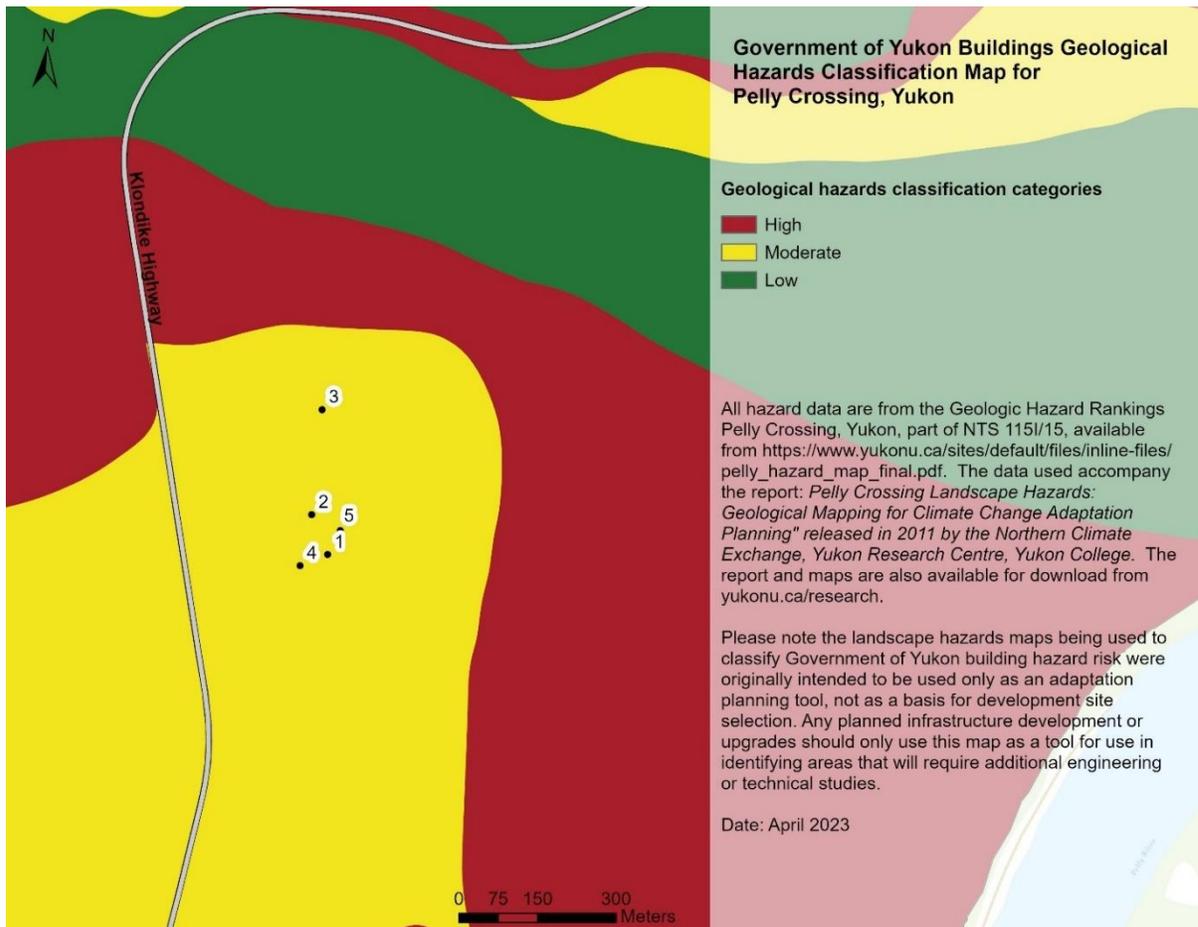
Figure 3.8.1 Government of Yukon Buildings Geological Hazards Classification Map for Pelly Crossing.

Red: High - Unstable landform. Likely to be affected by mass movement, thermokarst, subsidence, bank erosion, flooding or instability. These landforms typically consist of glacial diamicts, colluvial materials, glaciolacustrine, lacustrine and fluvial deposits. They are generally moderately to poorly drained and have shallow to steep slopes. High hazard landforms may have a significant thickness of permafrost containing high ice contents, be prone to gravity-induced erosion, and occur within the floodplain of the Pelly River. High hazard landforms are likely to become either more or less stable under predicted changes in climate

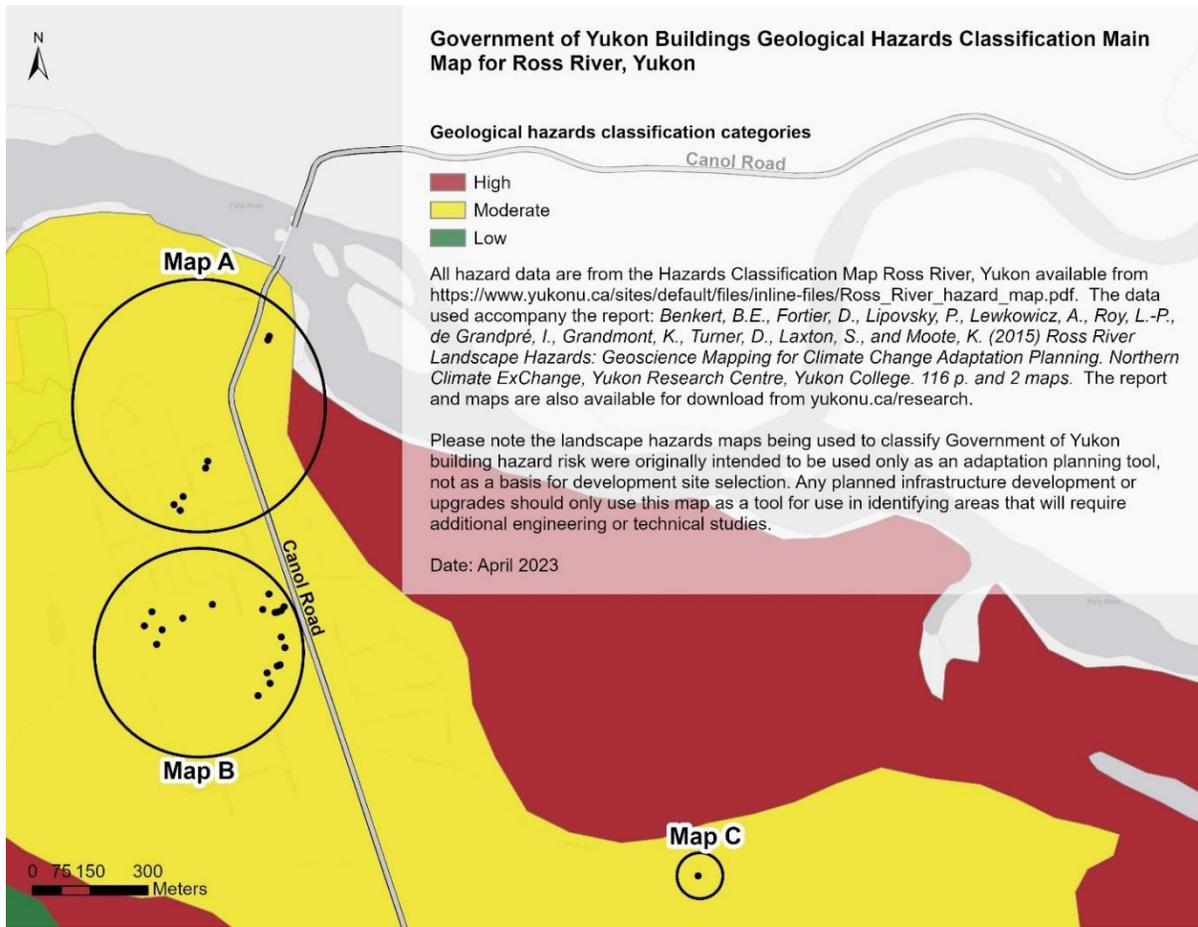
Figure 3.9.1 Government of Yukon Buildings Geological Hazards Classification Main Map for Ross River.

Green: low risk of hazards following permafrost degradation or low risk of geomorphic hazards.

Red: high risk of hazards following permafrost degradation (e.g., high thaw settlement, water ponding, and slow to rapid mass movement on slopes) and/or high risk of geomorphic hazards (e.g., gullying, flooding, steep slopes).

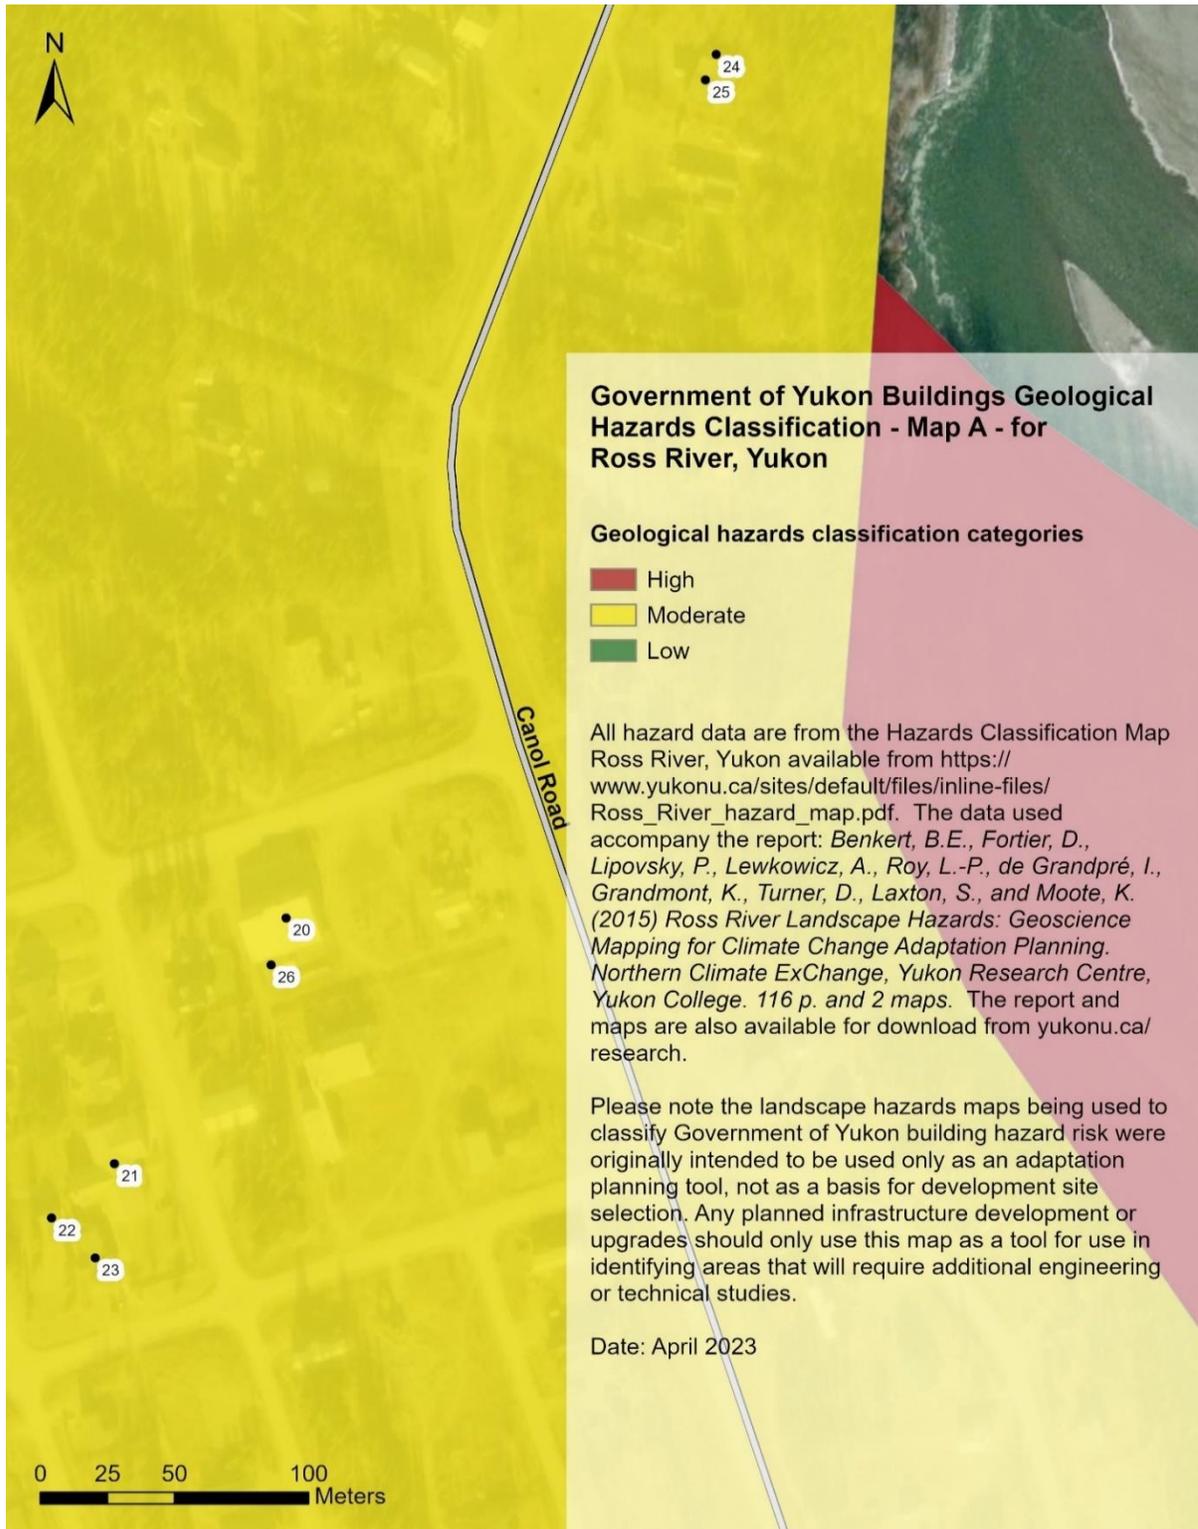
Figure 3.9.2 Government of Yukon Buildings Geological Hazards Classification – Map A - for Ross River.

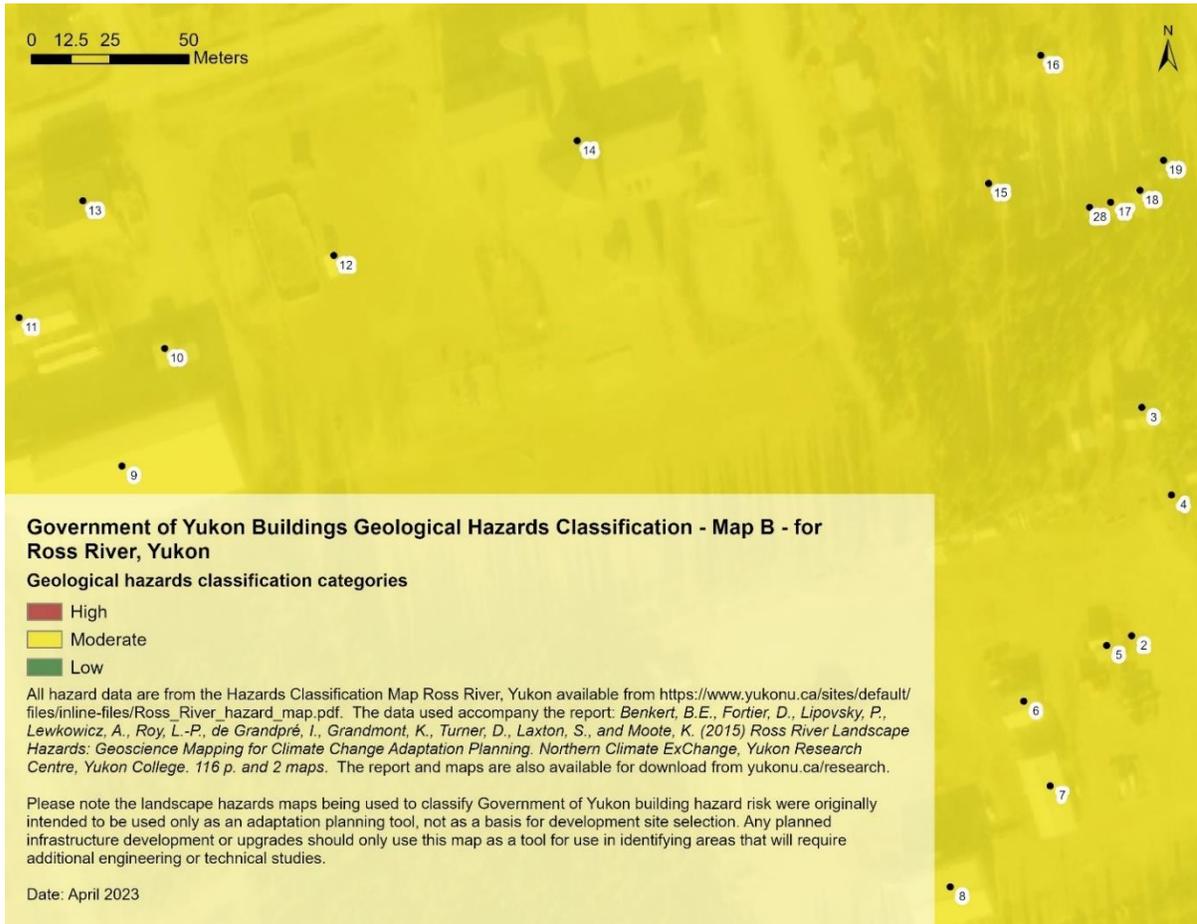
Figure 3.9.3 Government of Yukon Buildings Geological Hazards Classification – Map B - for Ross River.

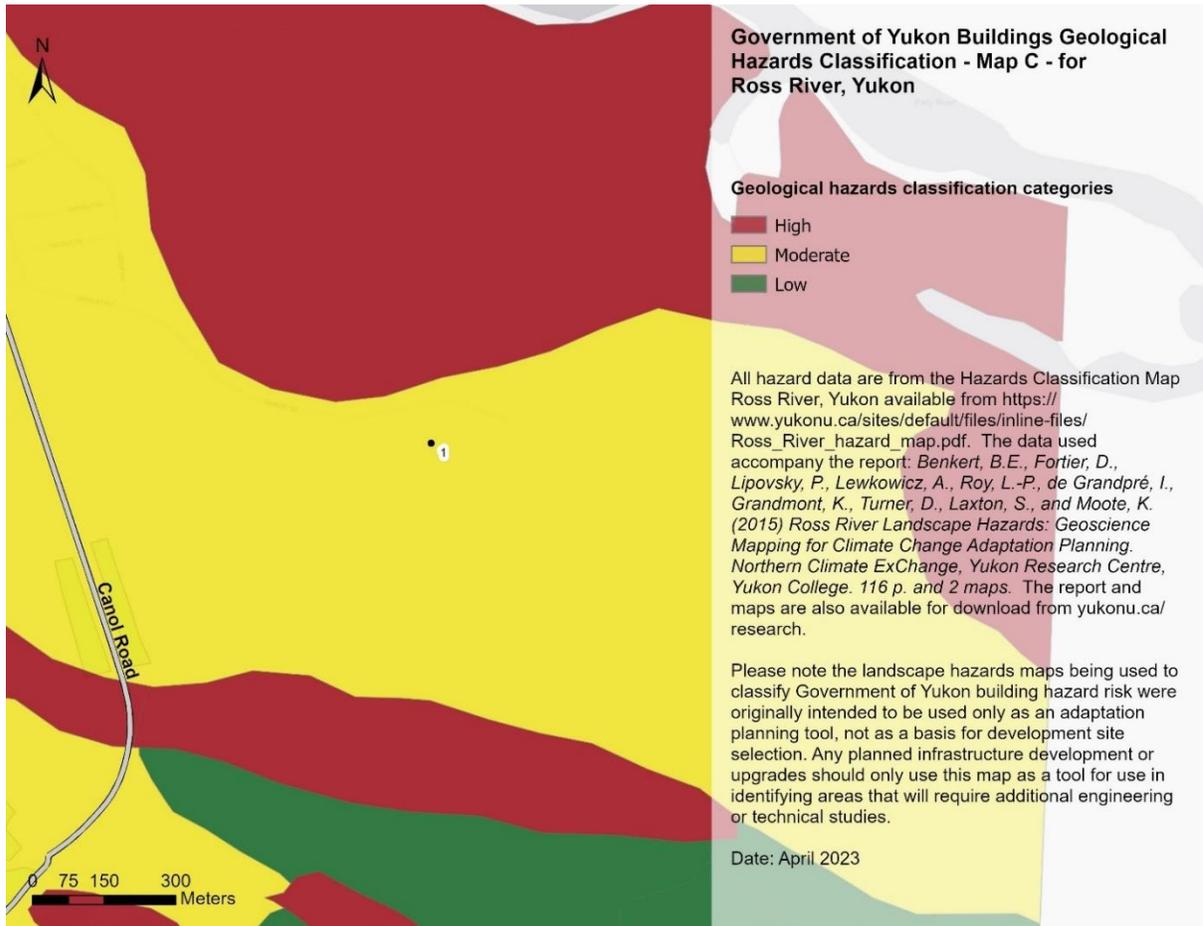
Figure 3.9.4 Government of Yukon Buildings Geological Hazards Classification – Map C - for Ross River.

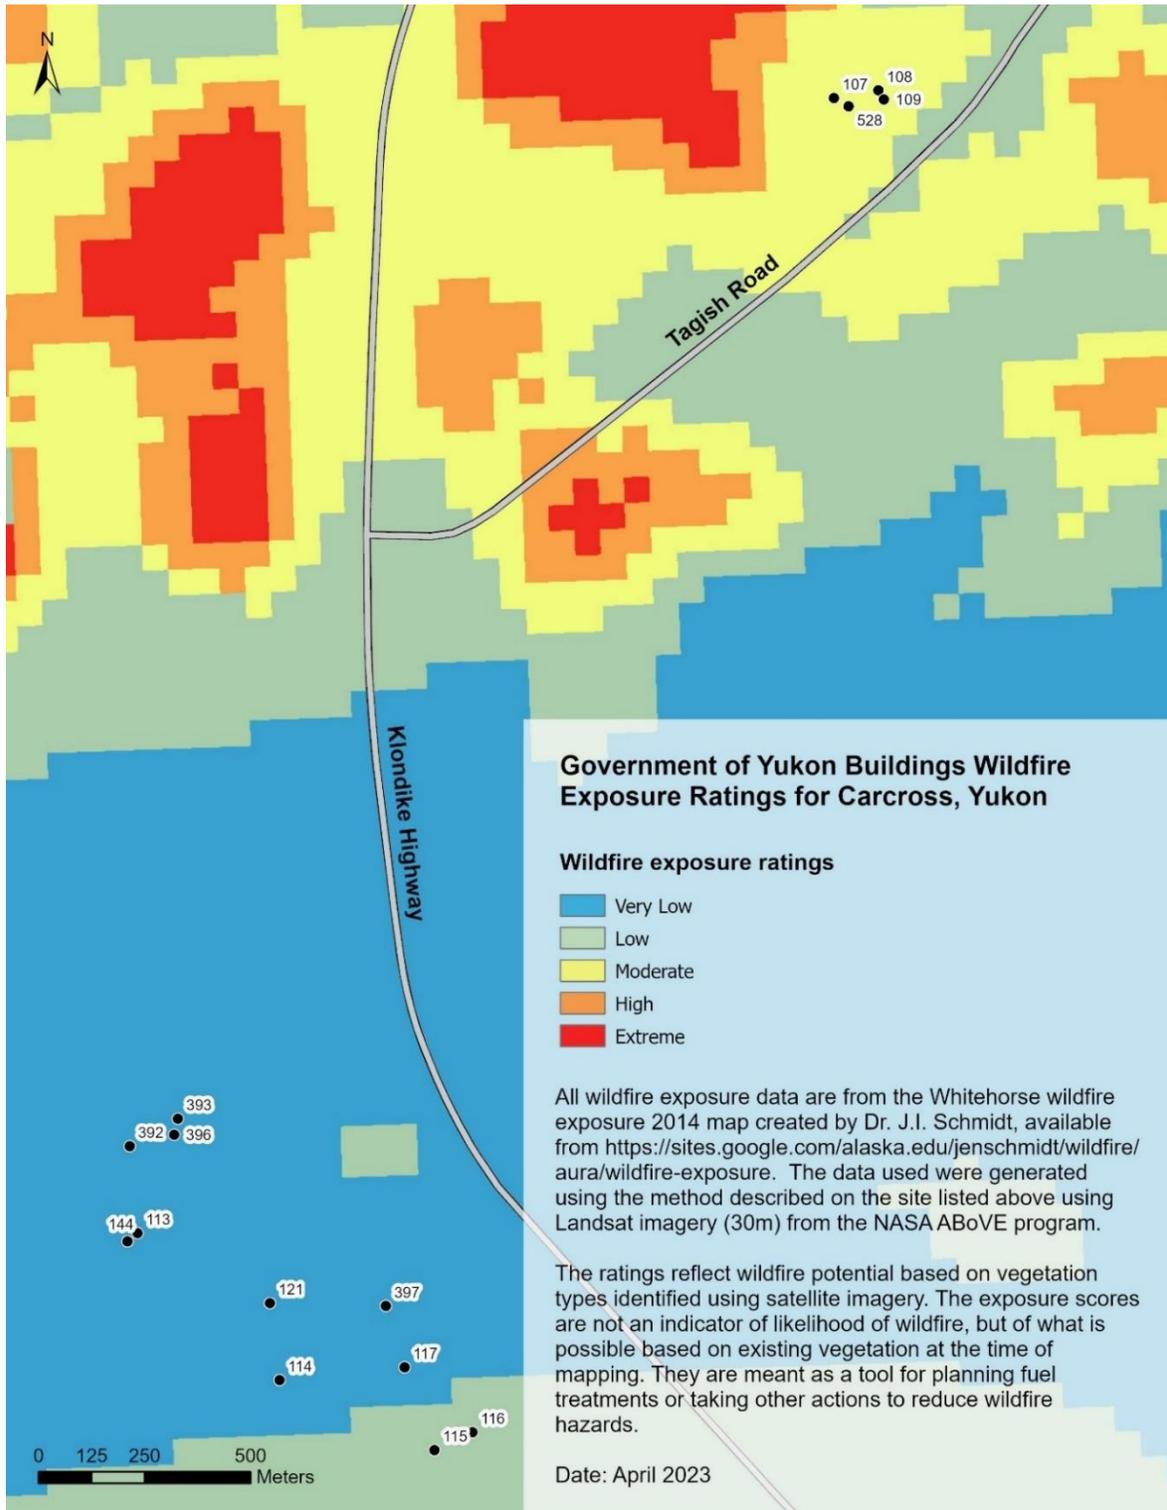
Figure 3.10.1 Government of Yukon Buildings Wildfire Exposure Ratings for Carcross, Yukon.

Extreme: 80-100, considerable exposure to hazardous/highly flammable vegetation in the surrounding area.

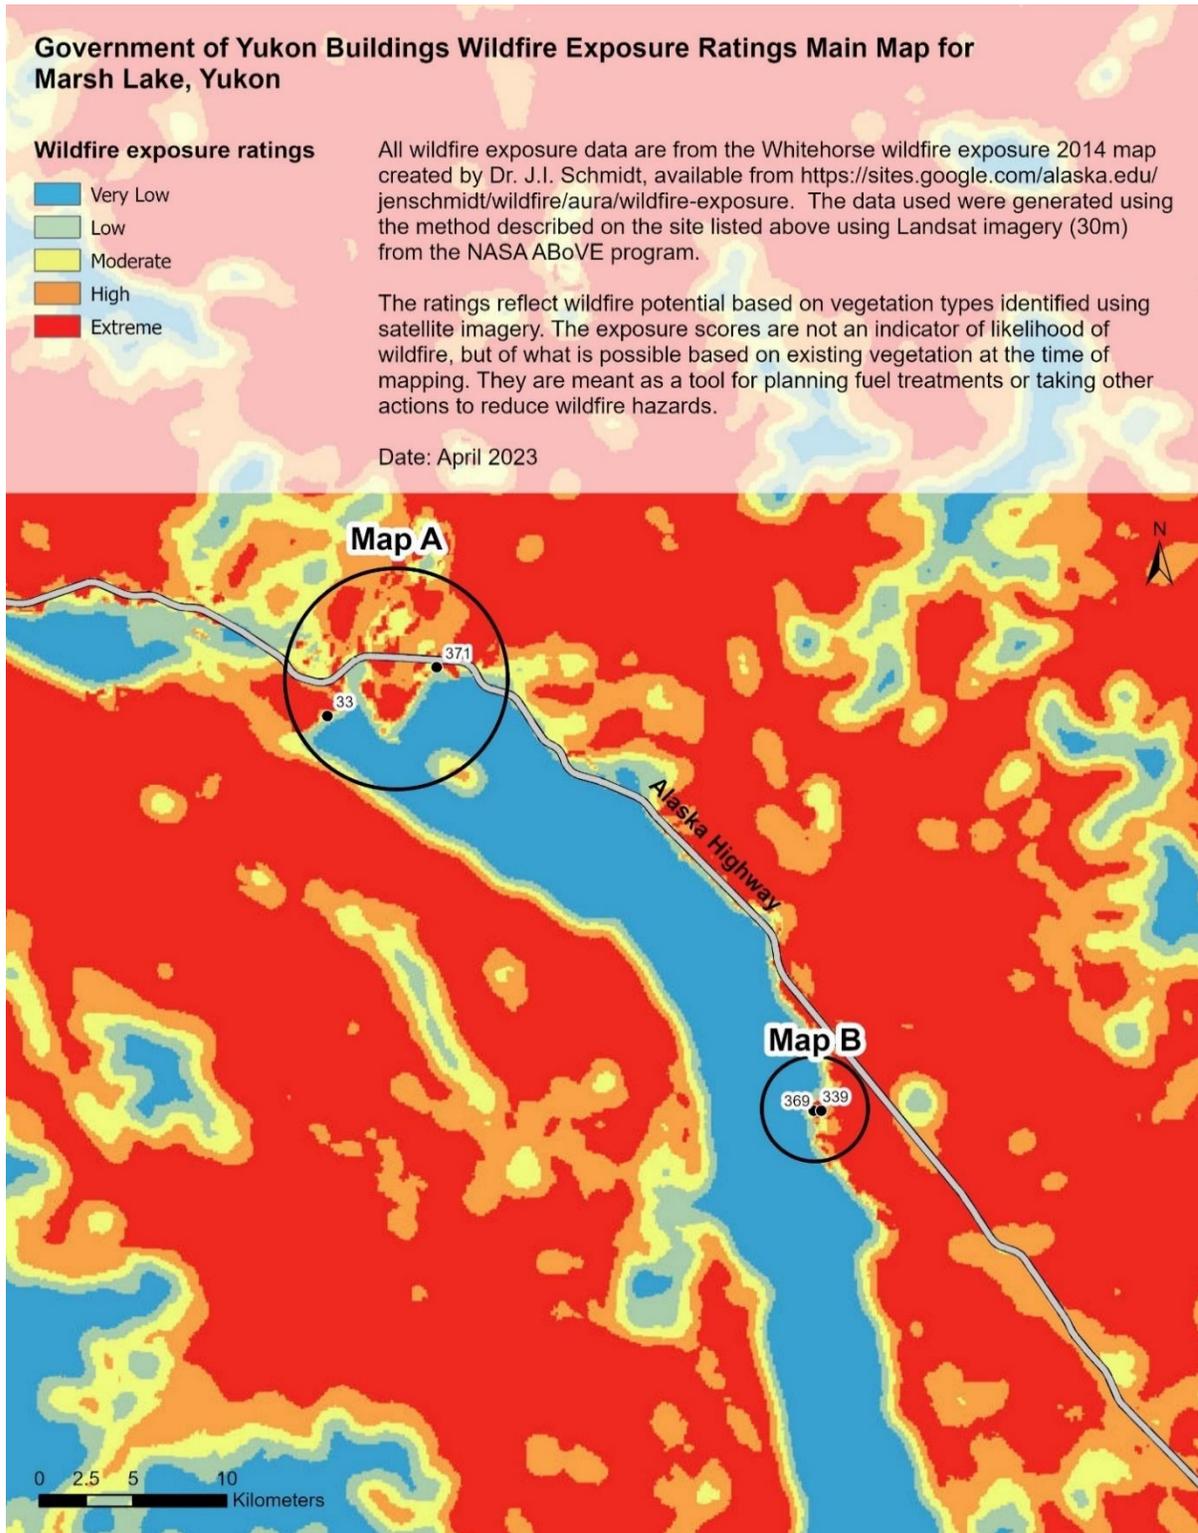
Figure 3.10.2 Government of Yukon Buildings Wildfire Exposure Ratings Main Map for Marsh Lake, Yukon.

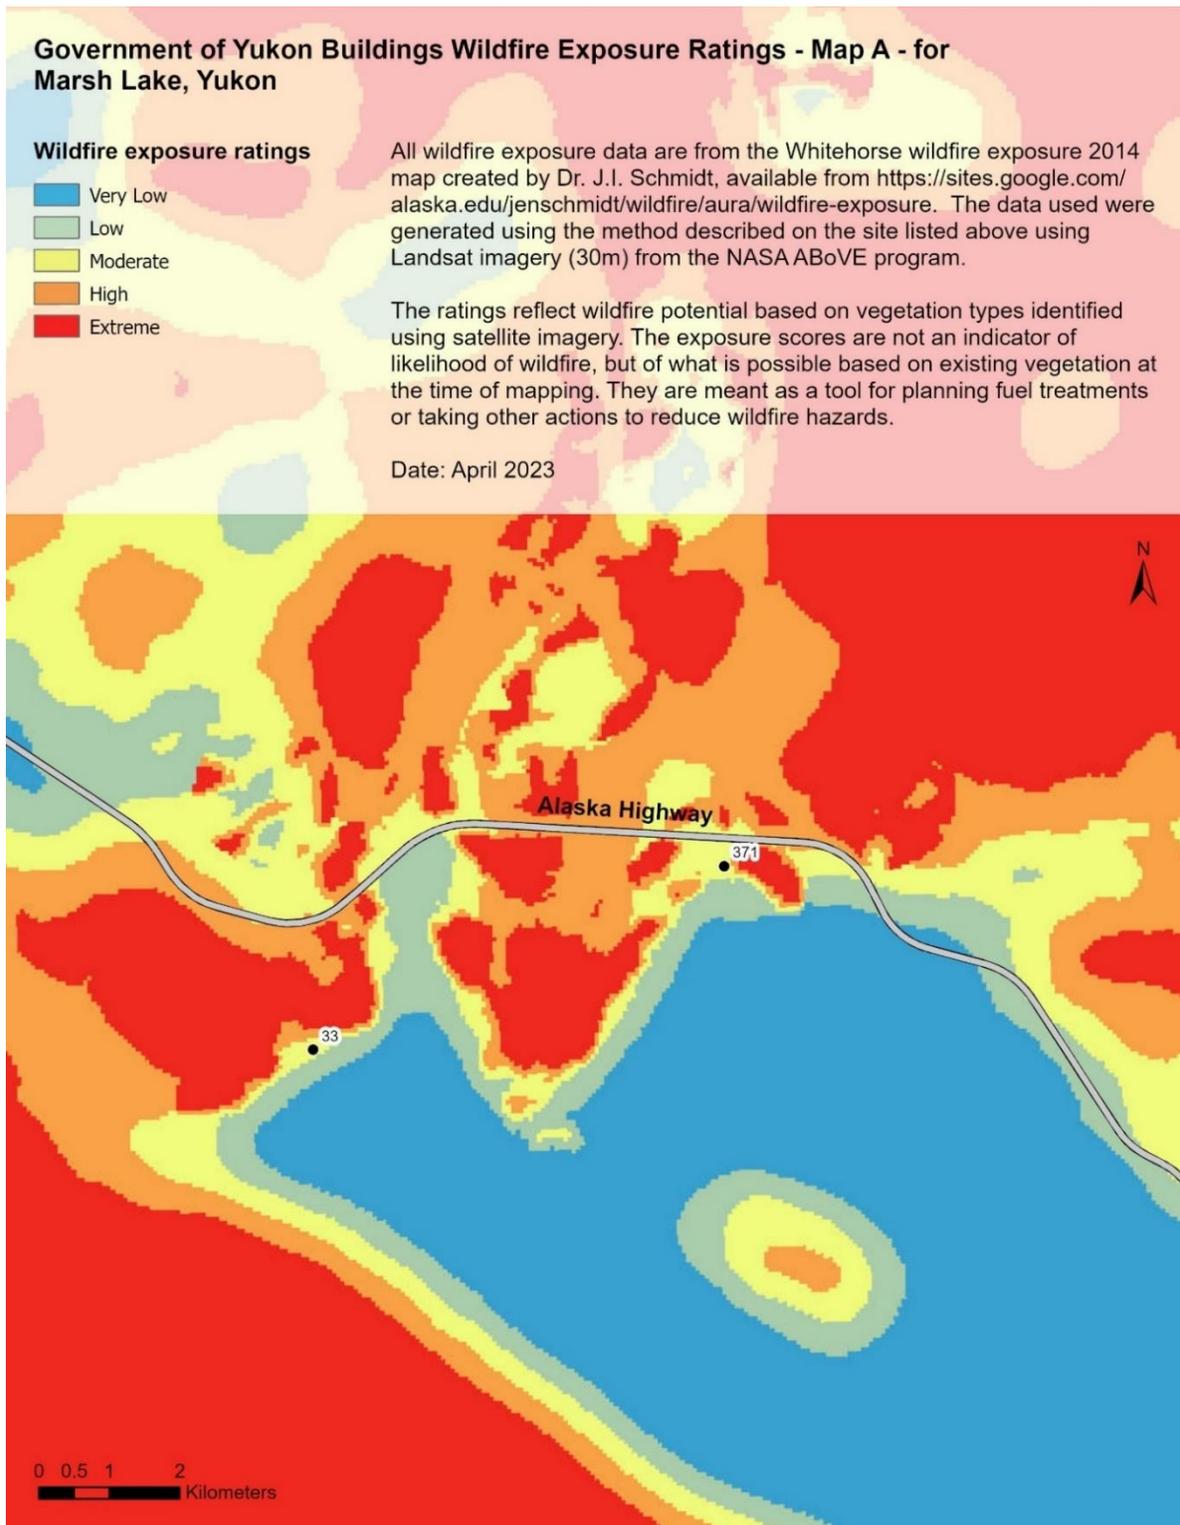
Figure 3.10.3 Government of Yukon Buildings Wildfire Exposure Ratings – Map A - for Marsh Lake, Yukon.

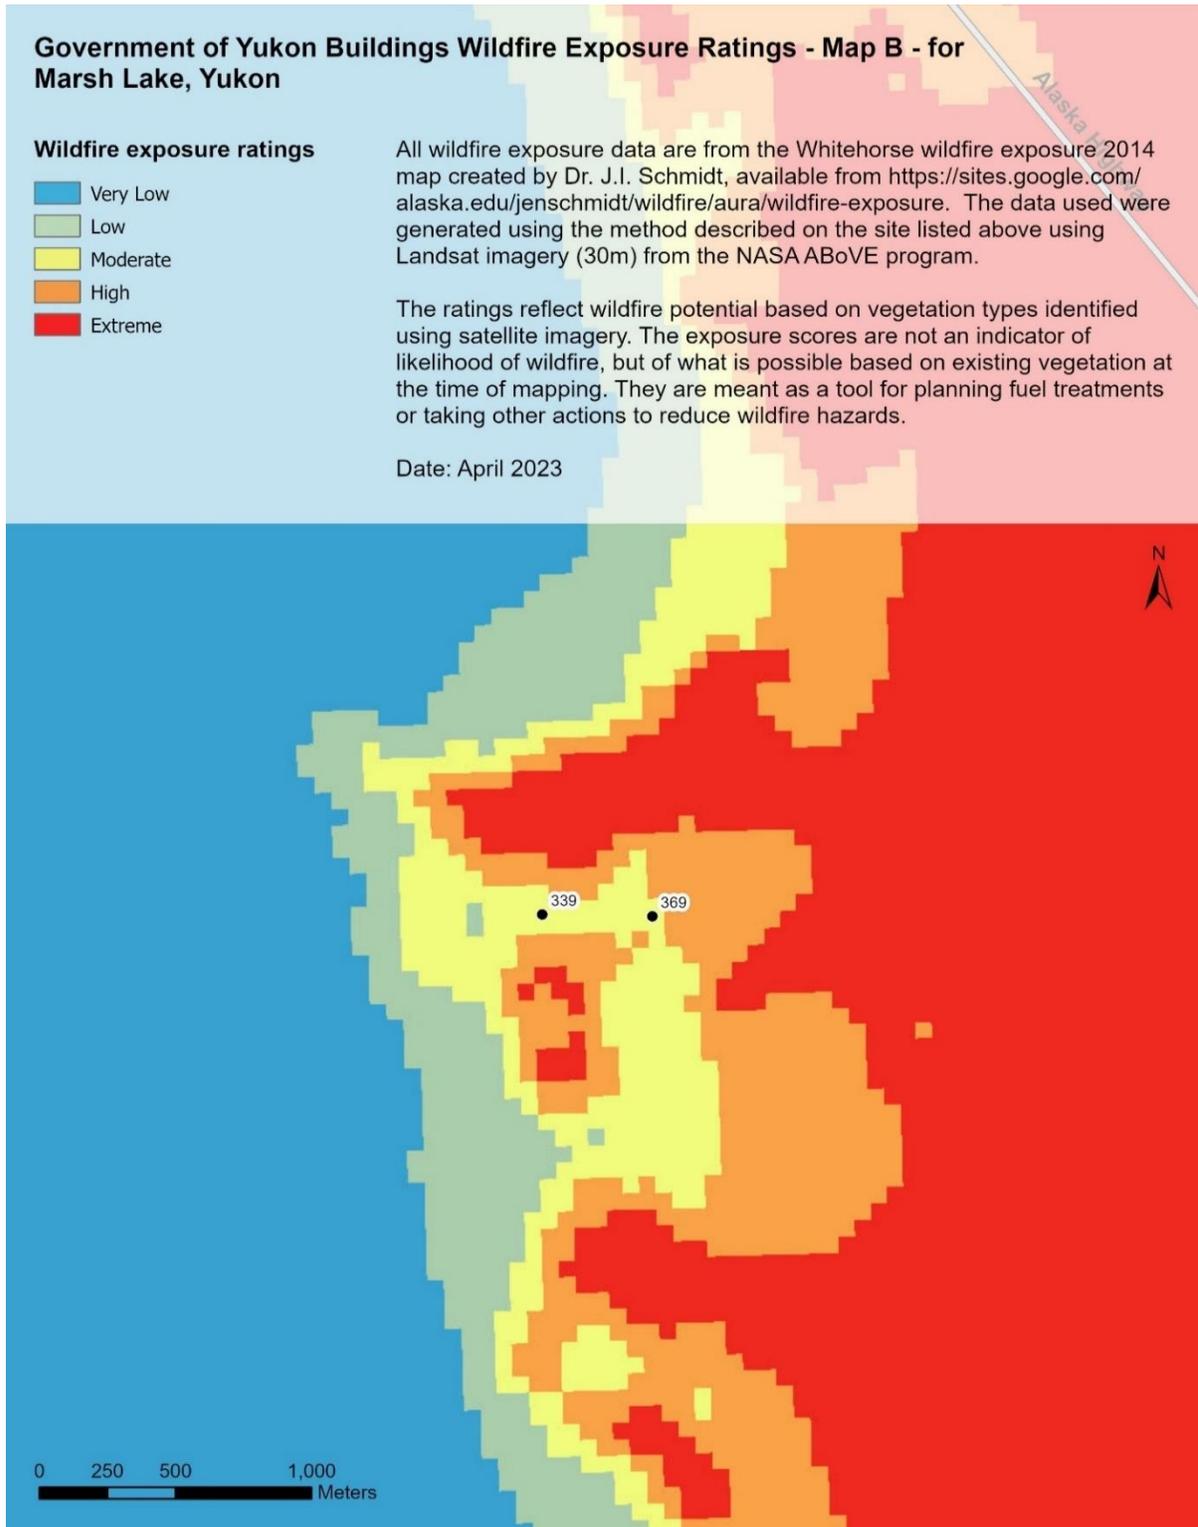
Figure 3.10.4 Government of Yukon Buildings Wildfire Exposure Ratings – Map B - for Marsh Lake, Yukon.

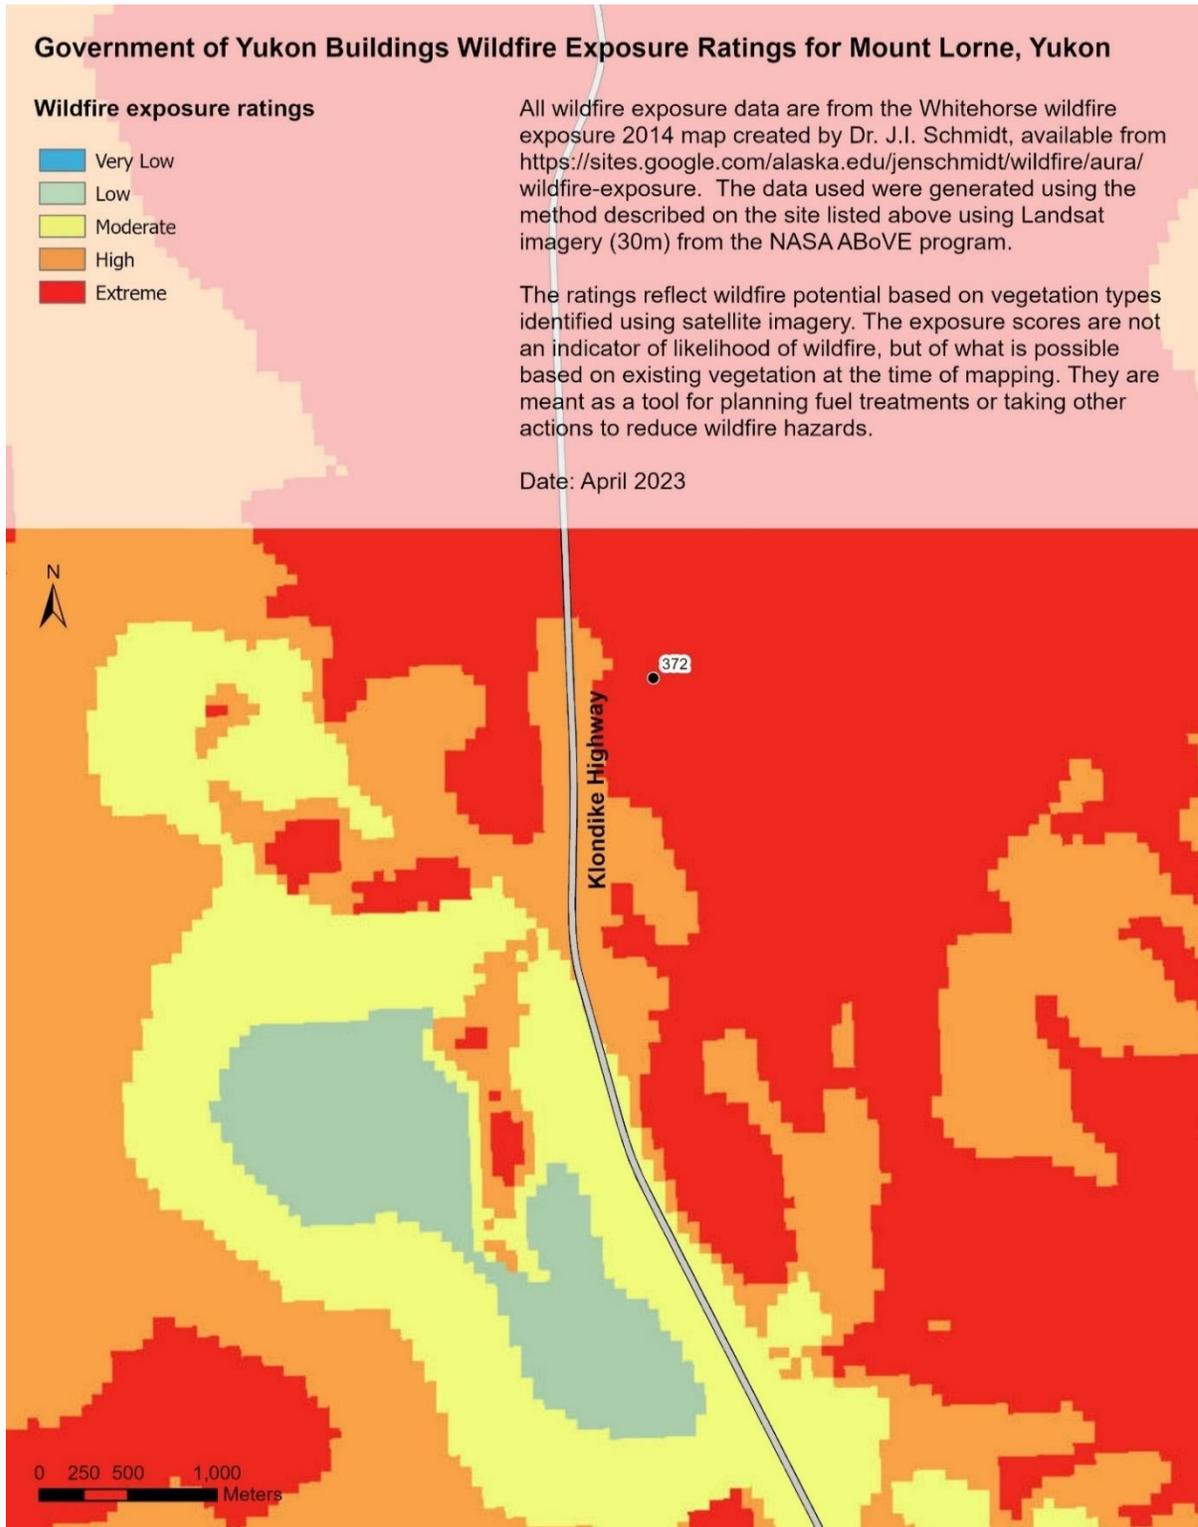
Figure 3.10.5 Government of Yukon Buildings Wildfire Exposure Ratings for Mount Lorne, Yukon.

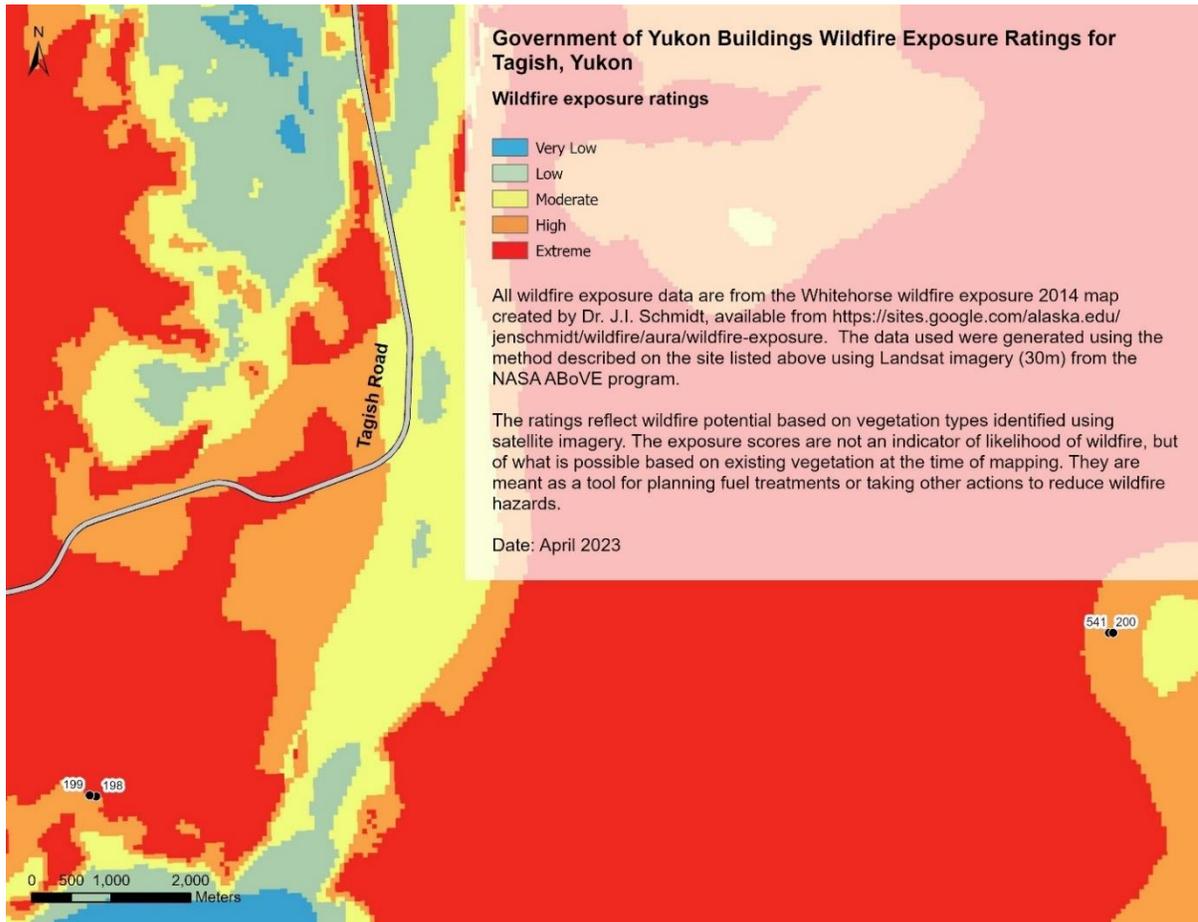
Figure 3.10.6 Government of Yukon Buildings Wildfire Exposure Ratings for Tagish, Yukon.

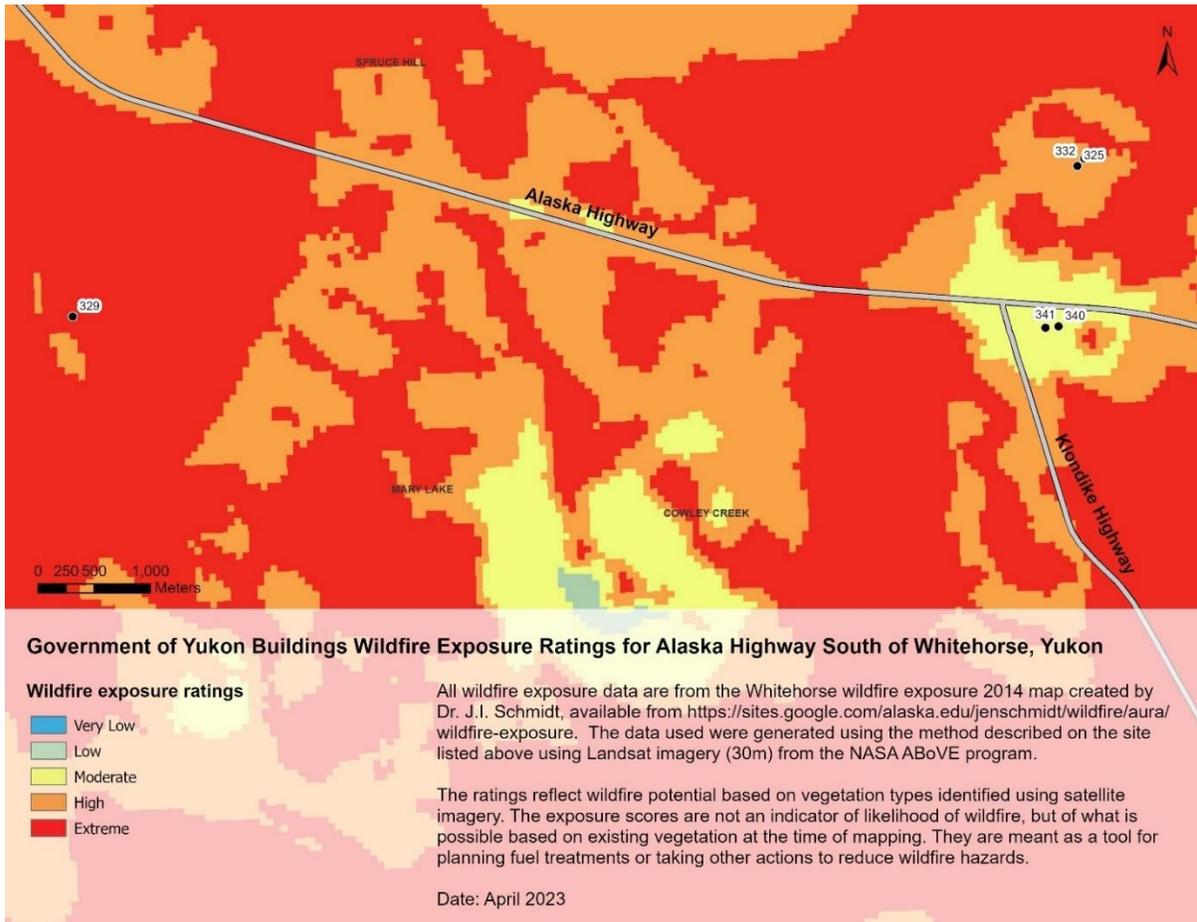
Figure 3.10.7 Government of Yukon Buildings Wildfire Exposure Ratings for Alaska Highway South of Whitehorse, Yukon.
