Climate risk mapping for Government of Yukon building assets

May 2023

Work on this project uses YG buildings as a case study for developing and testing these hazard exposure maps. This report outlines the methods and information used to create the maps developed and presented to the EMU. The maps and data are provided in an accessible and adaptable format so that they may be updated and/or adapted in the future.

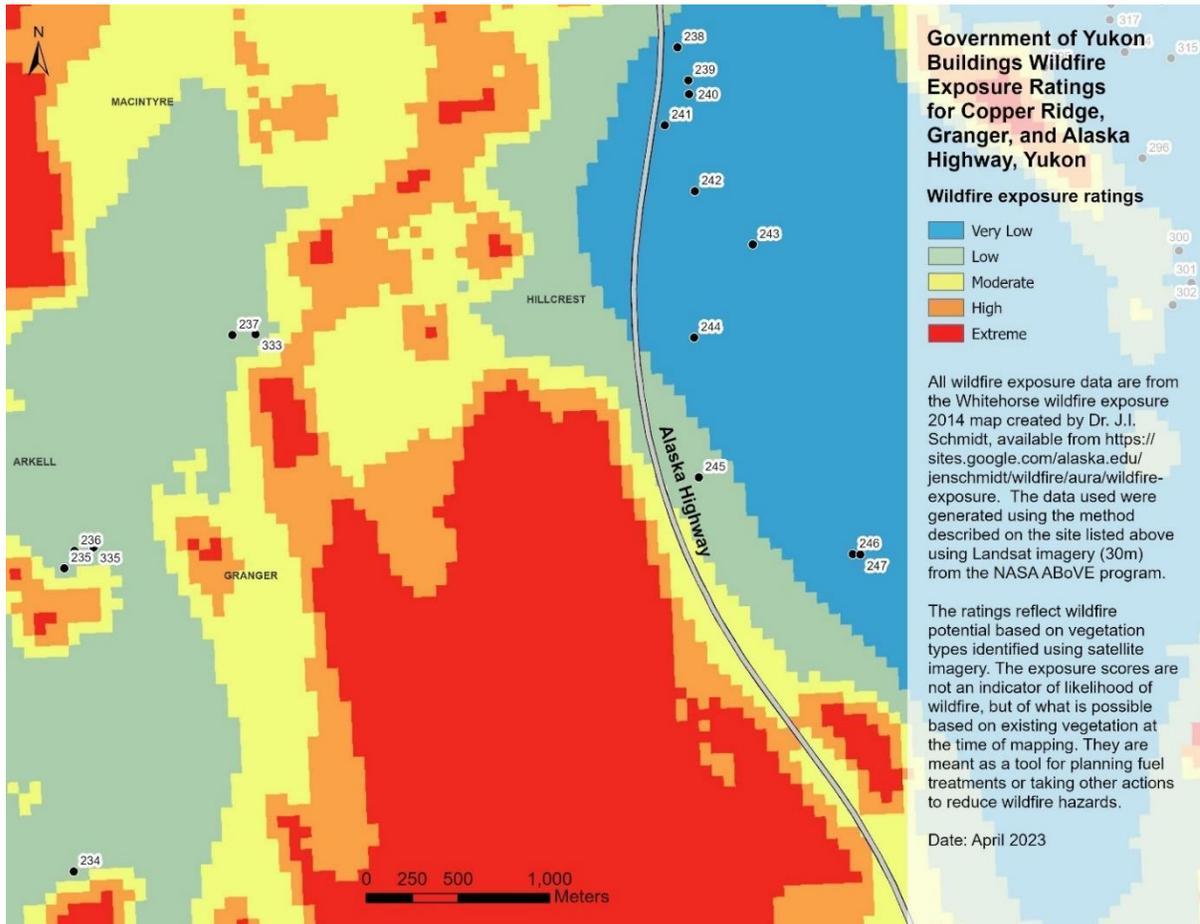
Figure 3.10.8 Government of Yukon Buildings Wildfire Exposure Ratings for Copper Ridge, Granger and Alaska Highway, Yukon.

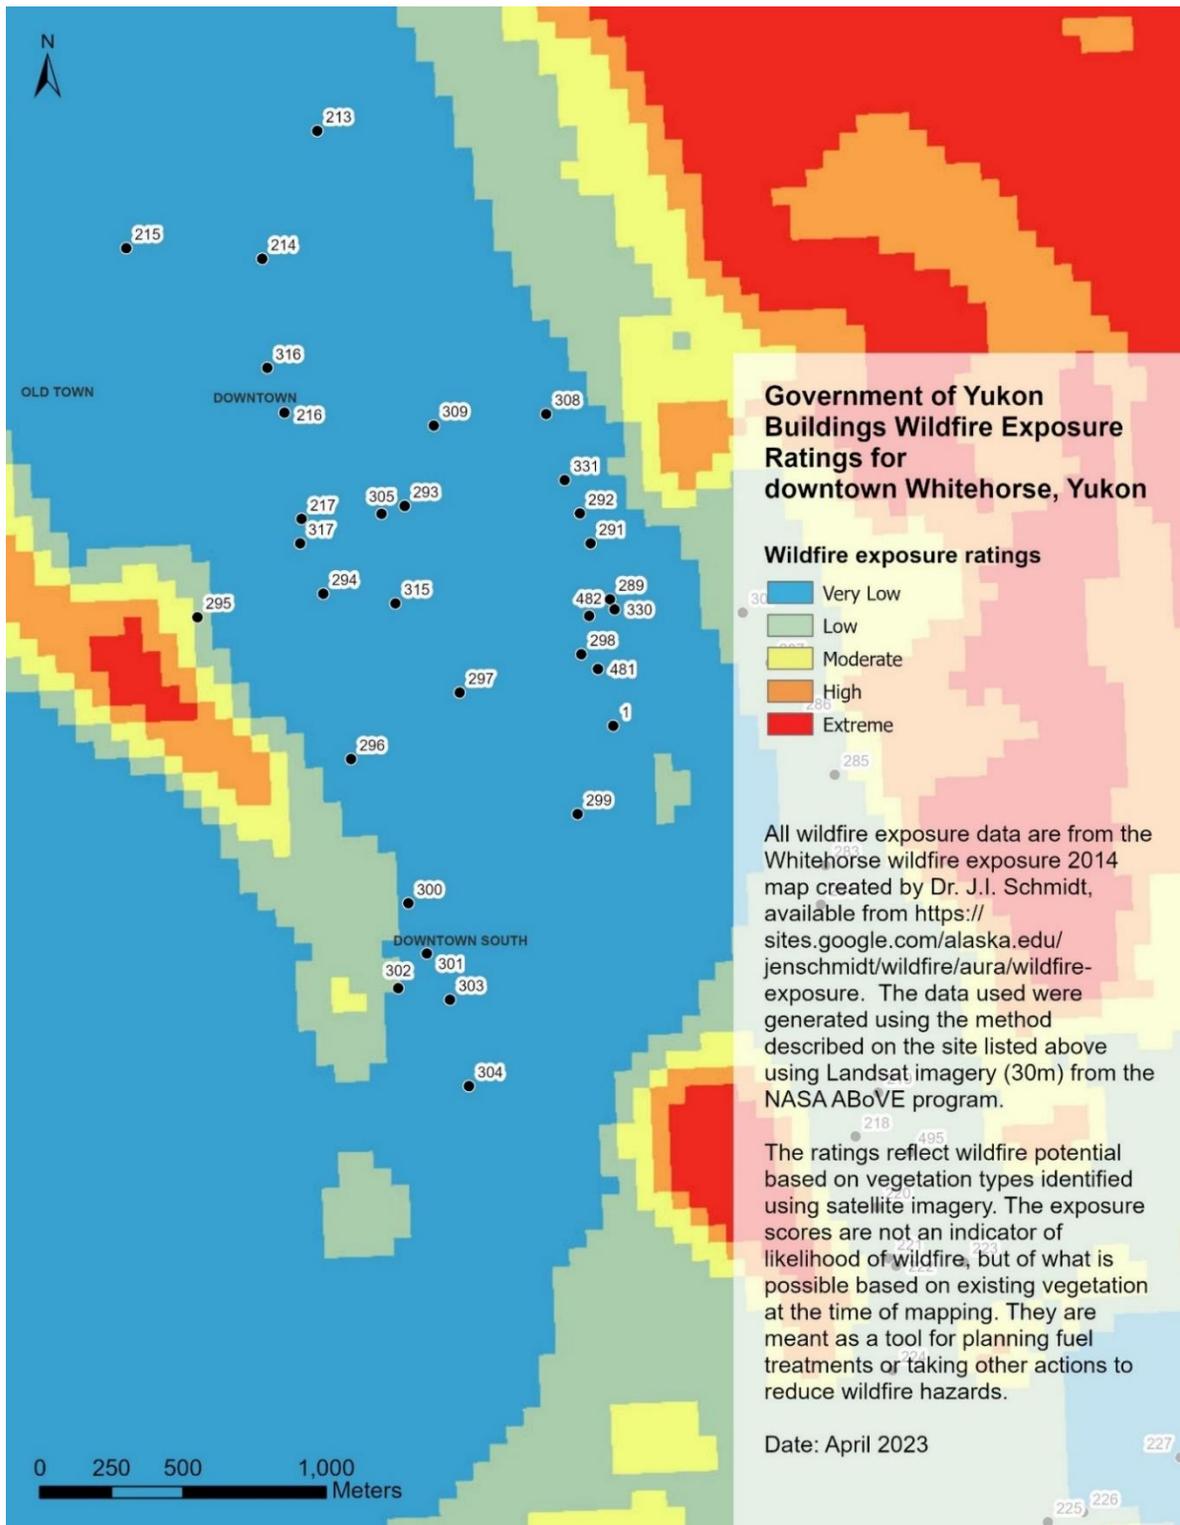
Figure 3.10.9 Government of Yukon Buildings Wildfire Exposure Ratings for Downtown Whitehorse, Yukon.

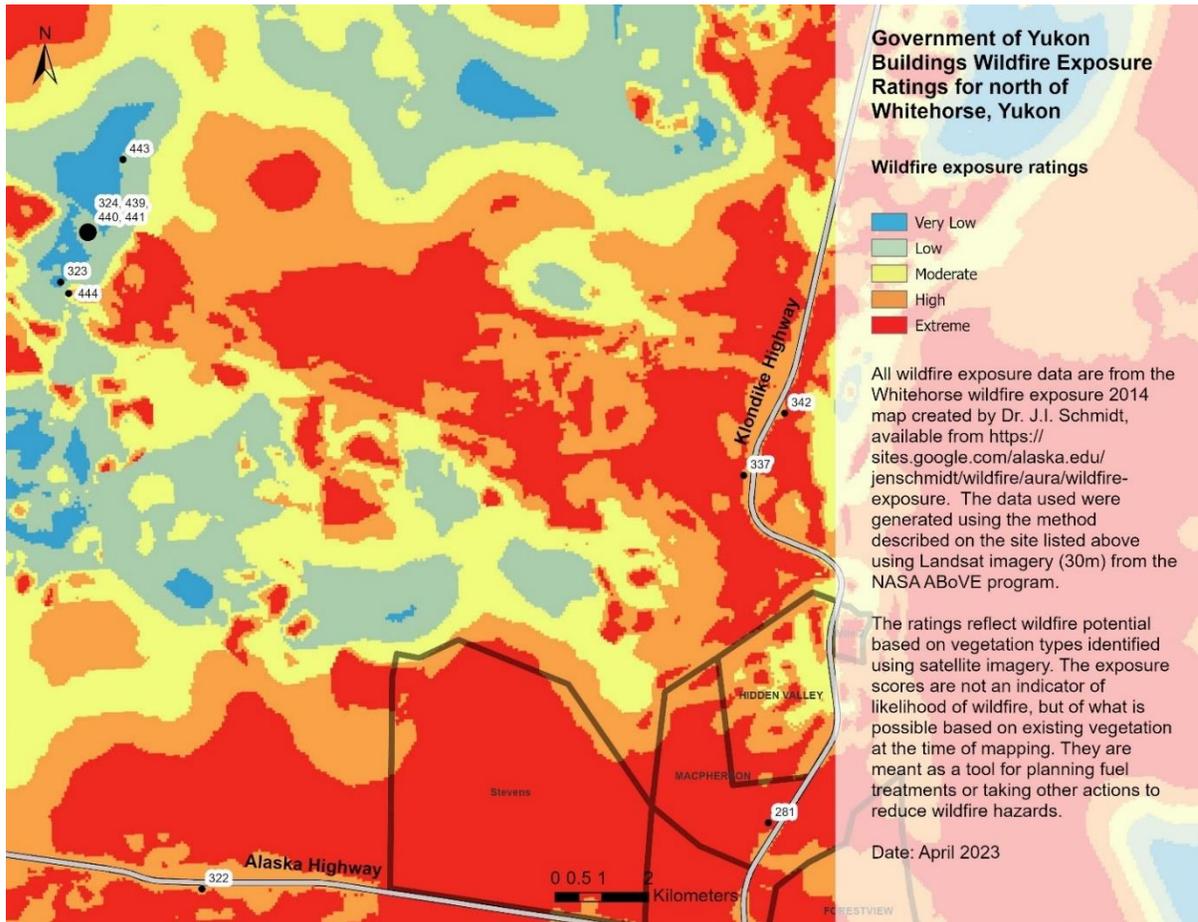
Figure 3.10.10 Government of Yukon Buildings Wildfire Exposure Ratings for North of Whitehorse, Yukon.

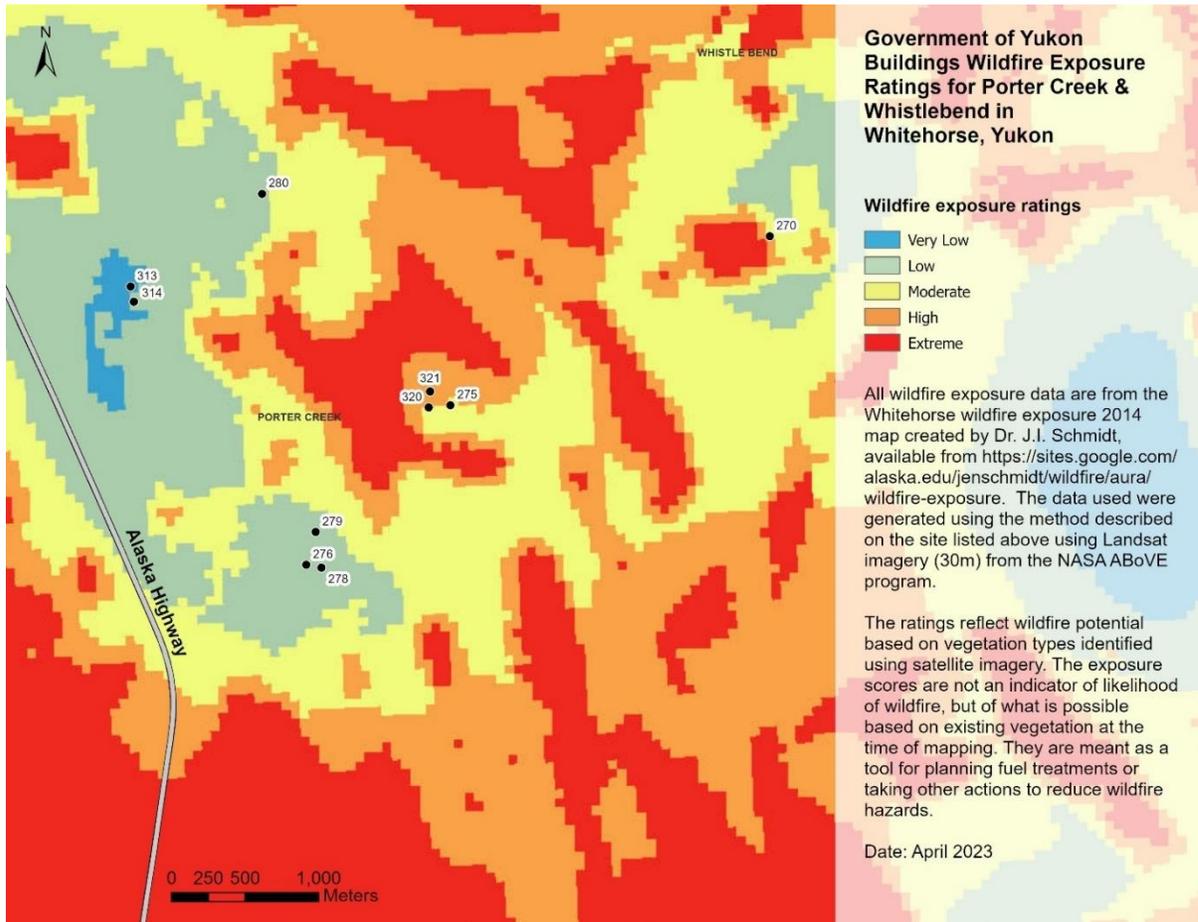
Figure 3.10.11 Government of Yukon Buildings Wildfire Exposure Ratings for Porter Creek & Whistlebend in Whitehorse, Yukon.

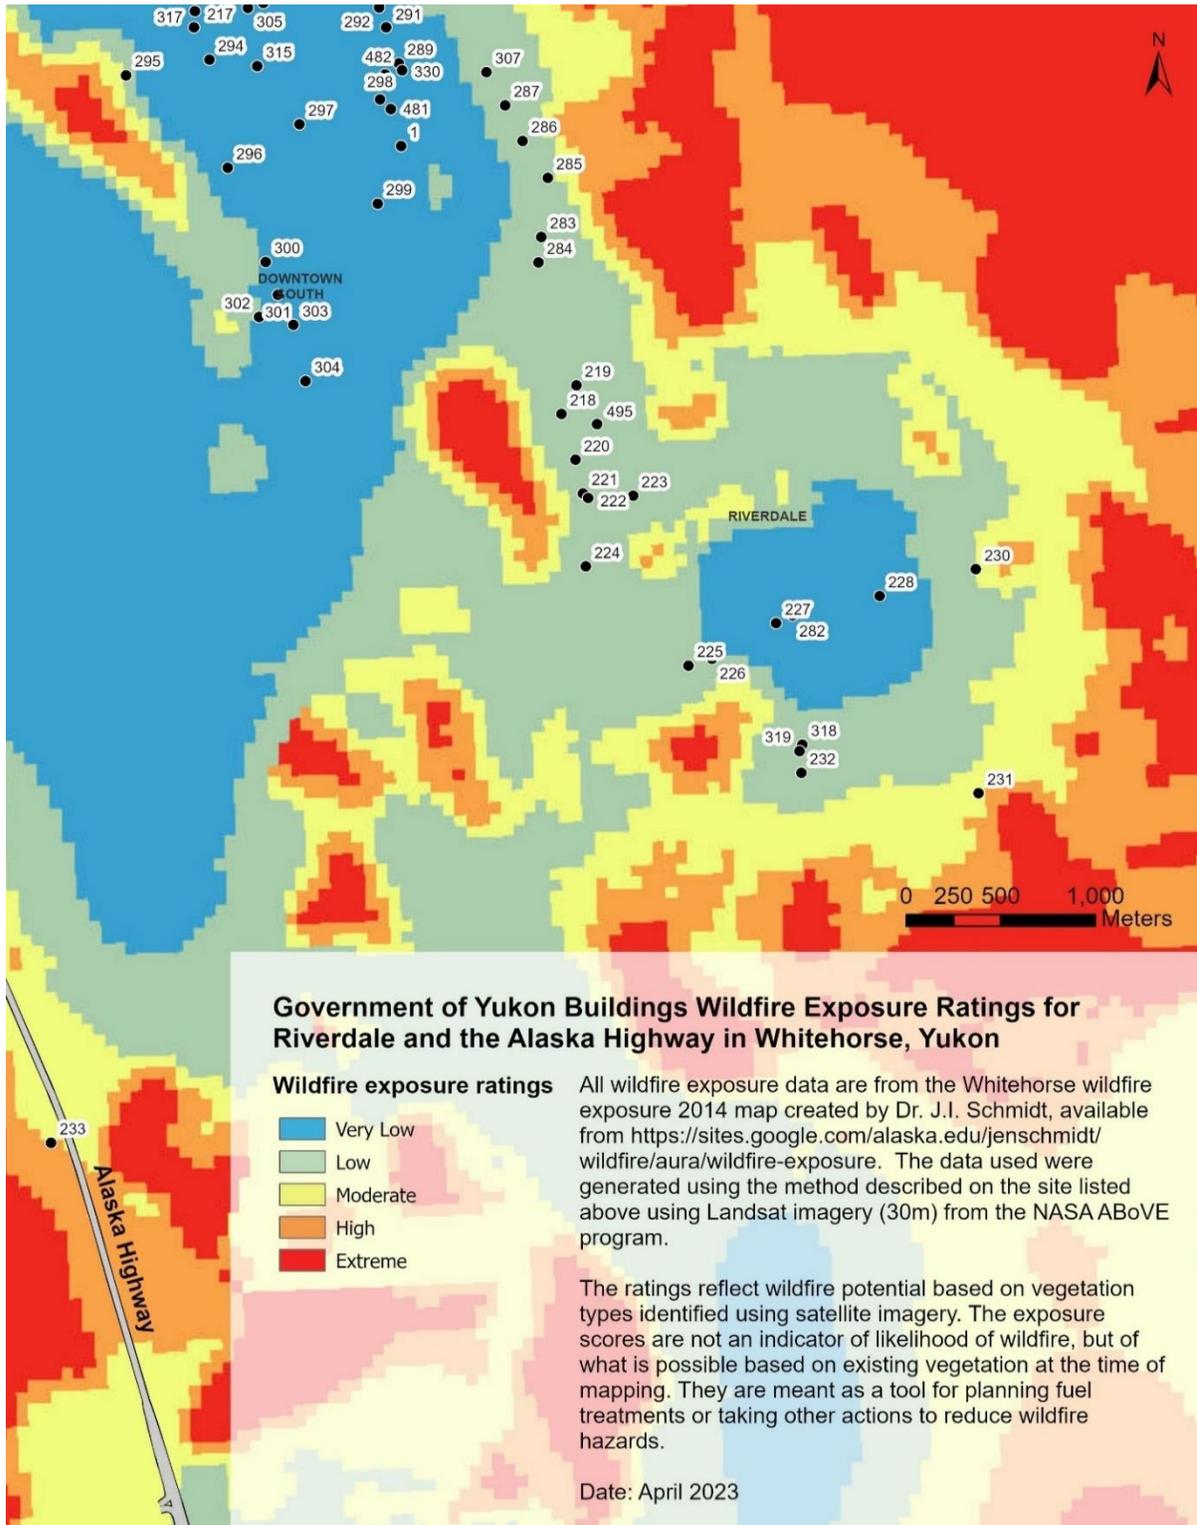
Figure 3.10.12 Government of Yukon Buildings Wildfire Exposure Ratings for Riverdale in Whitehorse, Yukon.

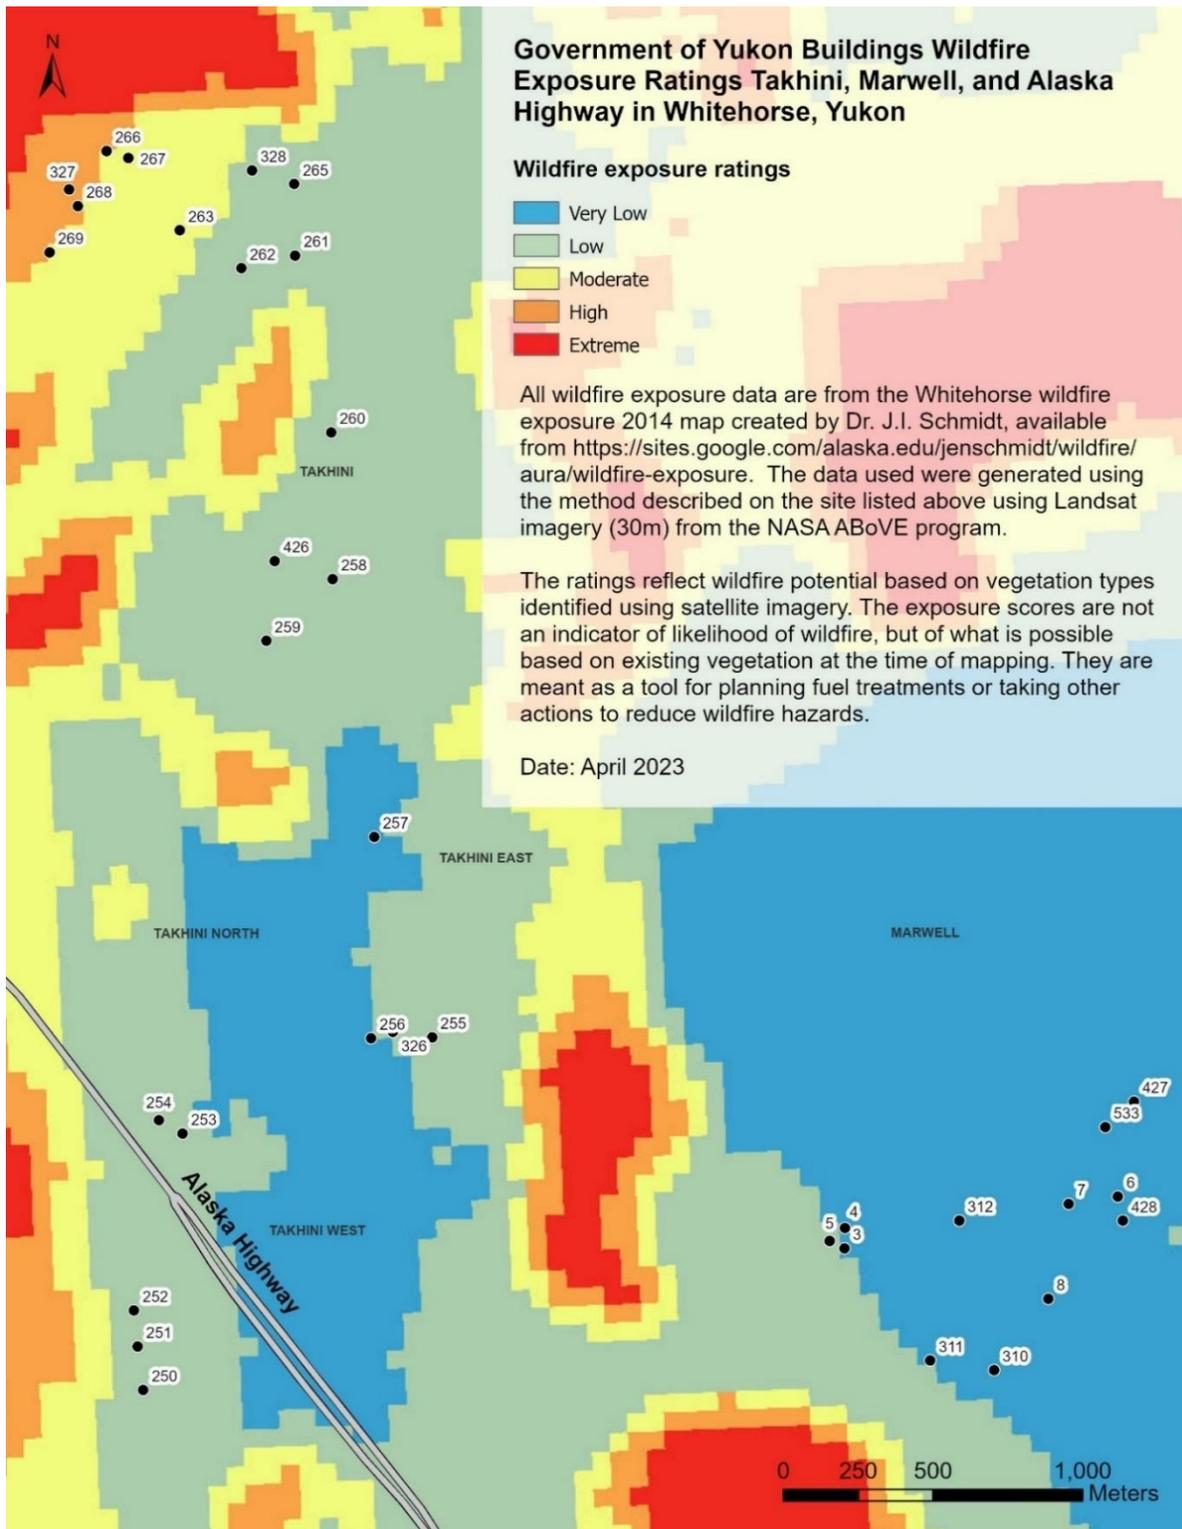
Figure 3.10.13 Government of Yukon Buildings Wildfire Exposure Ratings for Takhini and Marwell in Whitehorse, Yukon.
